# Iberian Peninsula Blackout - 28 April 2025

Overview of the event and the lessons for NZ

System Operator

June 2026

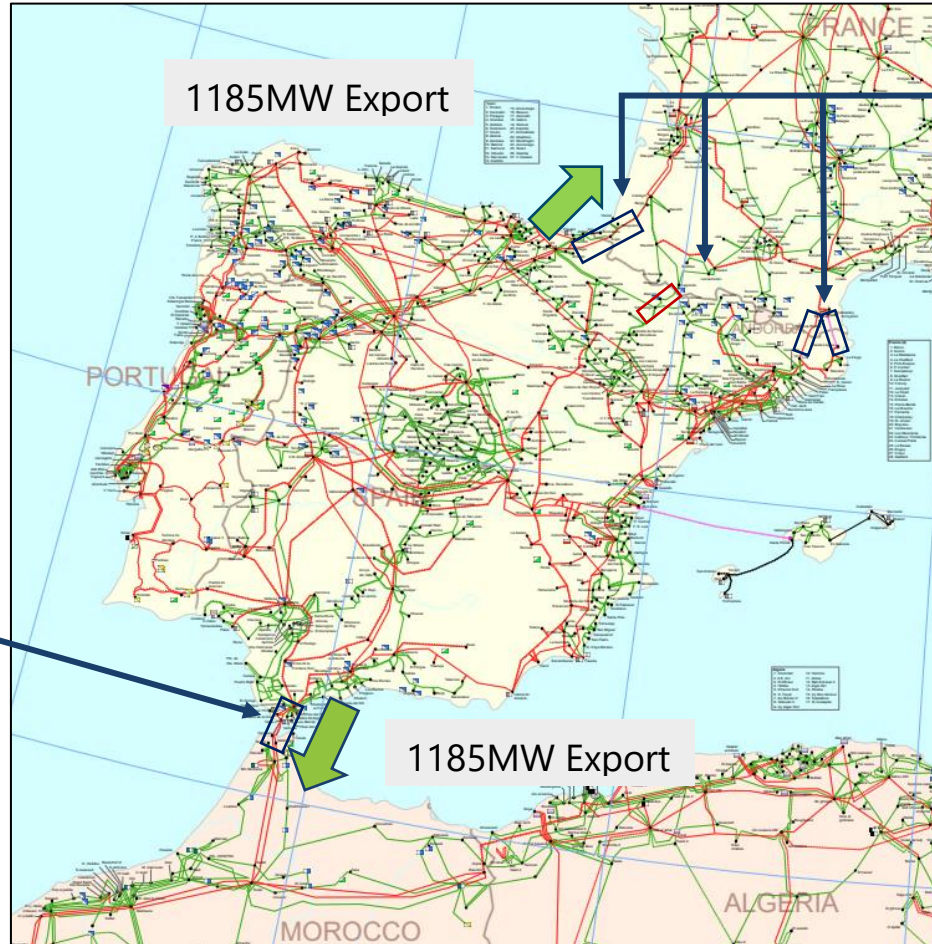
- 2x 400kV AC, 2x 220 kV AC,
- 1 HVDC.
- 2800 MW total capacity.
- 1 of the 220 kV lines (in red) was on planned outage prior to the blackout.

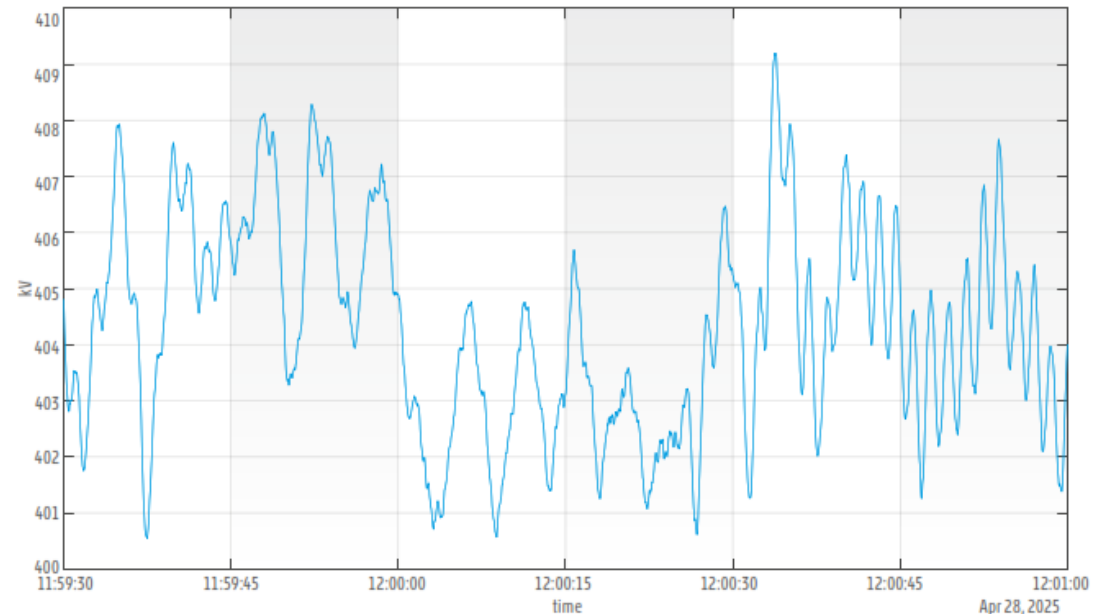
- 0.63 Hz oscillations in frequency and voltage in the Iberian Peninsula system. These were analysed post-event and determined to be local oscillations, likely generated from a control system injecting a periodic disturbance.
- A second 0.21 Hz oscillation 12 minutes later, corresponding to a known European inter-area mode, involving groups of generators.

0.63 Hz voltage oscillations prior to the event.  
Source: ENTSO-E final report

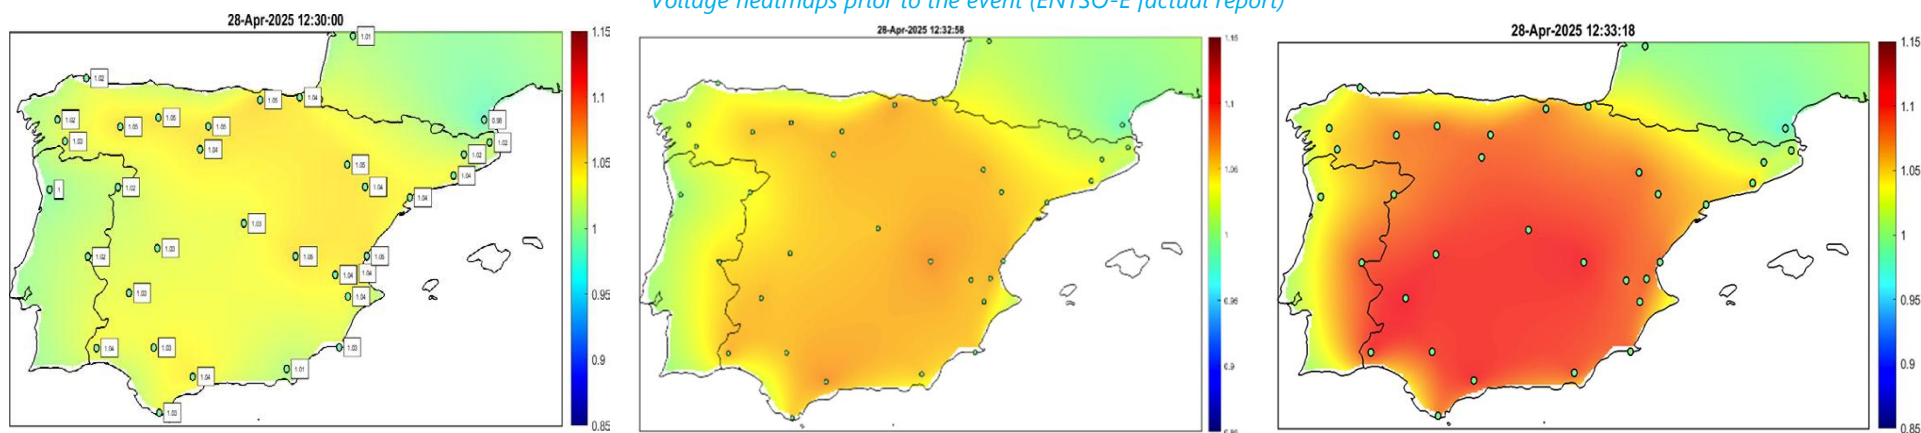
- The first generation transformer tripped in Southern Spain on overvoltage while the grid voltage was still within limits, removing ~355 MW of generation. This had the effect of increasing voltage further by reducing reactive power absorption.
- A further 725 MW generation tripped in Southwest Spain, leading to even higher voltages.
- A further 1100 MW generation tripped around the south and southwest of Spain.
- Over-voltages from the loss of these generators caused cascade generation over-voltage tripping through Spain.
- Spanish/Portuguese AUFLS equivalent activated, but this was insufficient to prevent collapse of the system.
- The Iberian Peninsula was disconnected from the rest of the European grid by protection action on HVDC links and AC interconnections. Spain and Portugal power systems blacked out.

*Voltage heatmaps prior to the event (ENTSO-E factual report)*

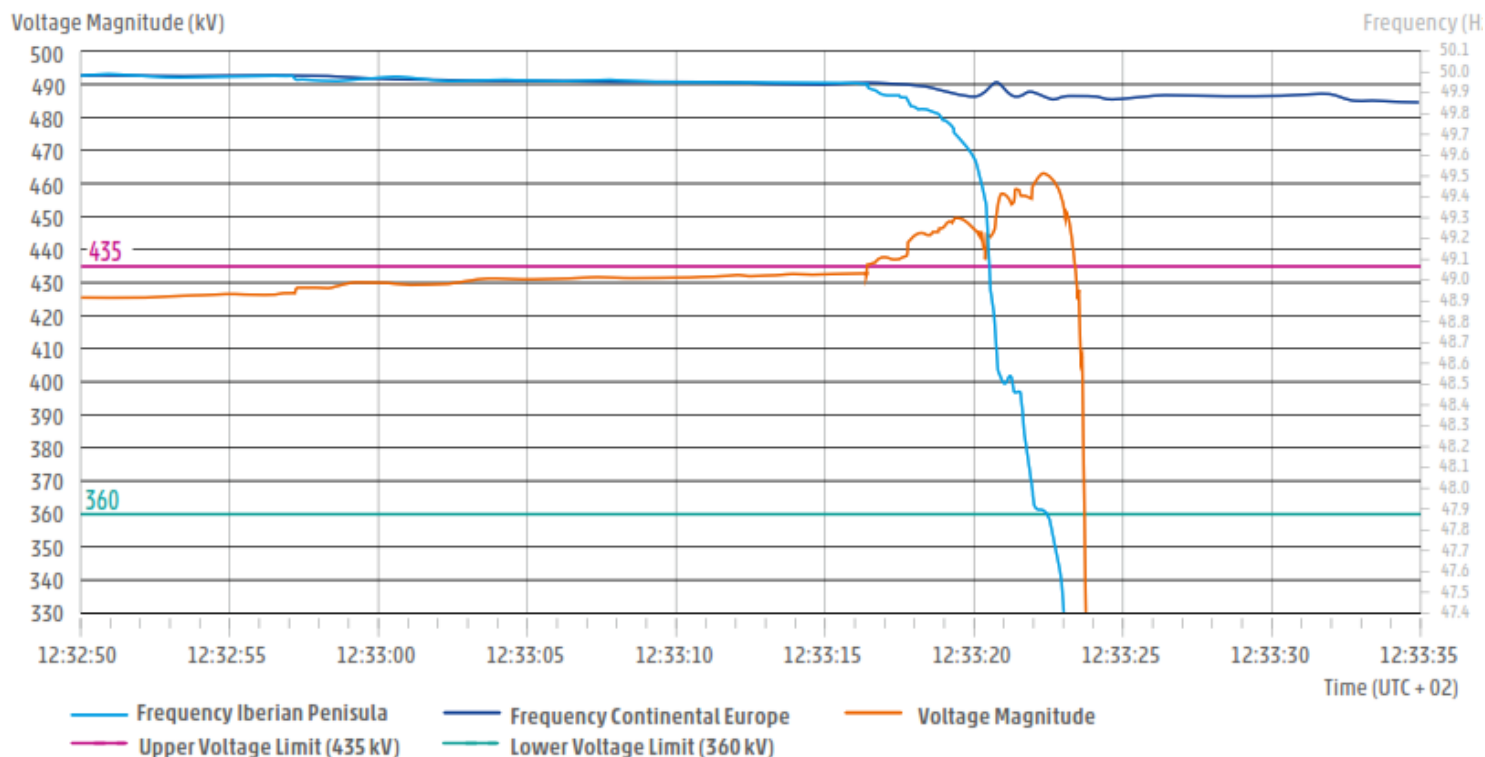
Evolution of frequency and voltage in Carmona (Spain) against frequency in Continental Europe.

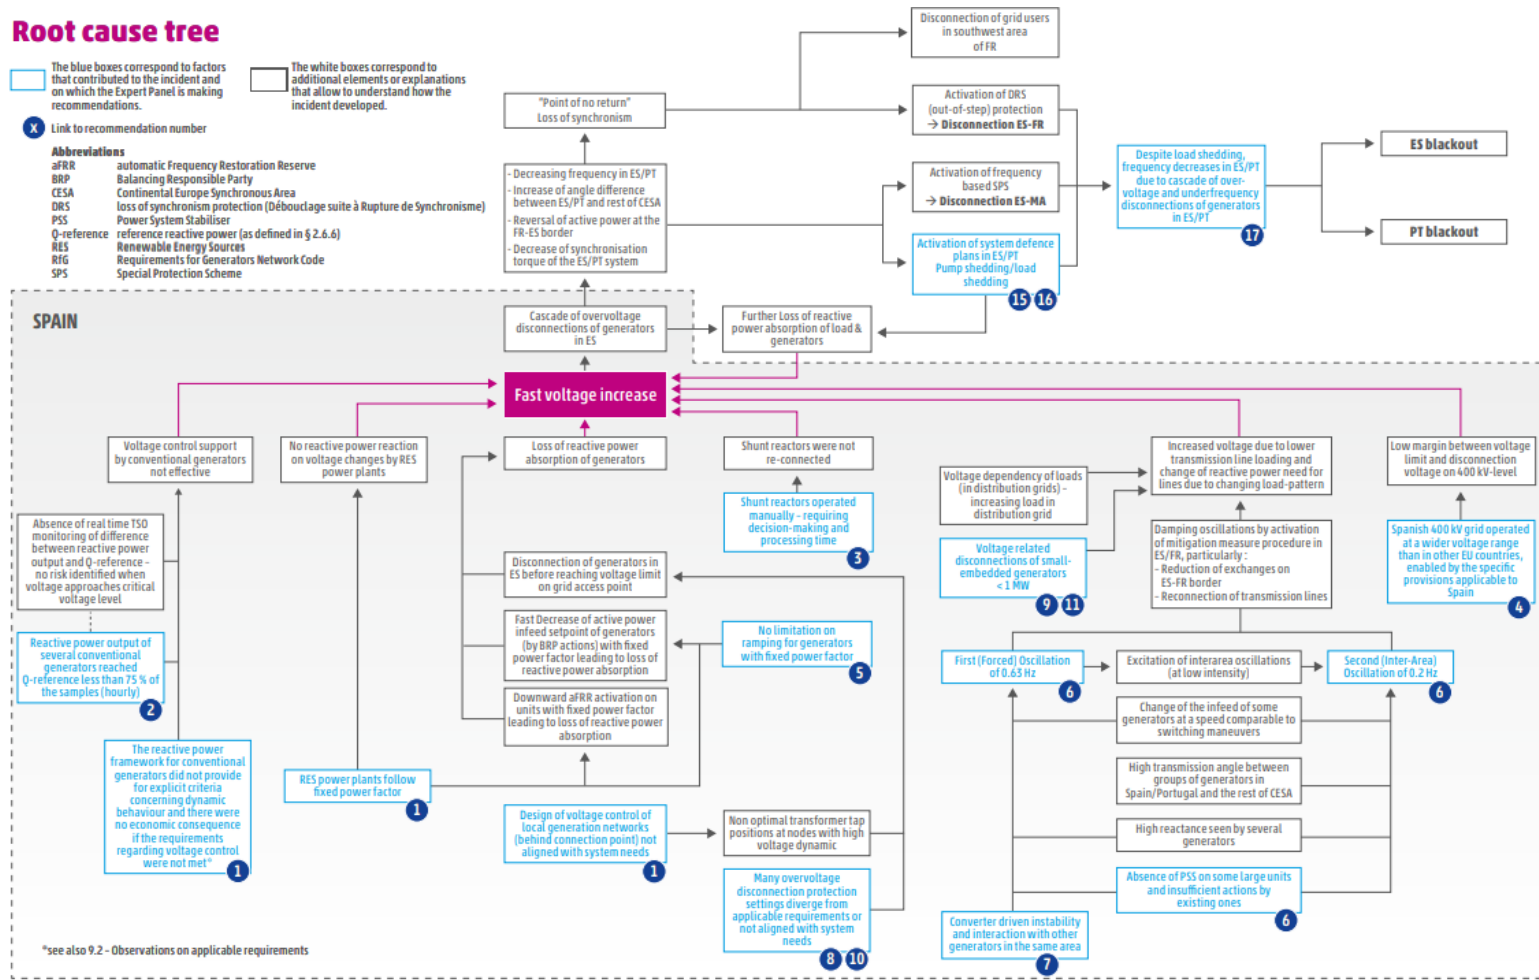
Figure 4-124: Root cause tree linked with recommendations

The blue boxes correspond to factors that contributed to the incident and on which the Expert Panel is making recommendations.

The white boxes correspond to additional elements or explanations that allow to understand how the incident developed.
