Iberian Peninsula Blackout - 28 April 2025

Overview of the event and the lessons for NZ

System Operator

June 2026

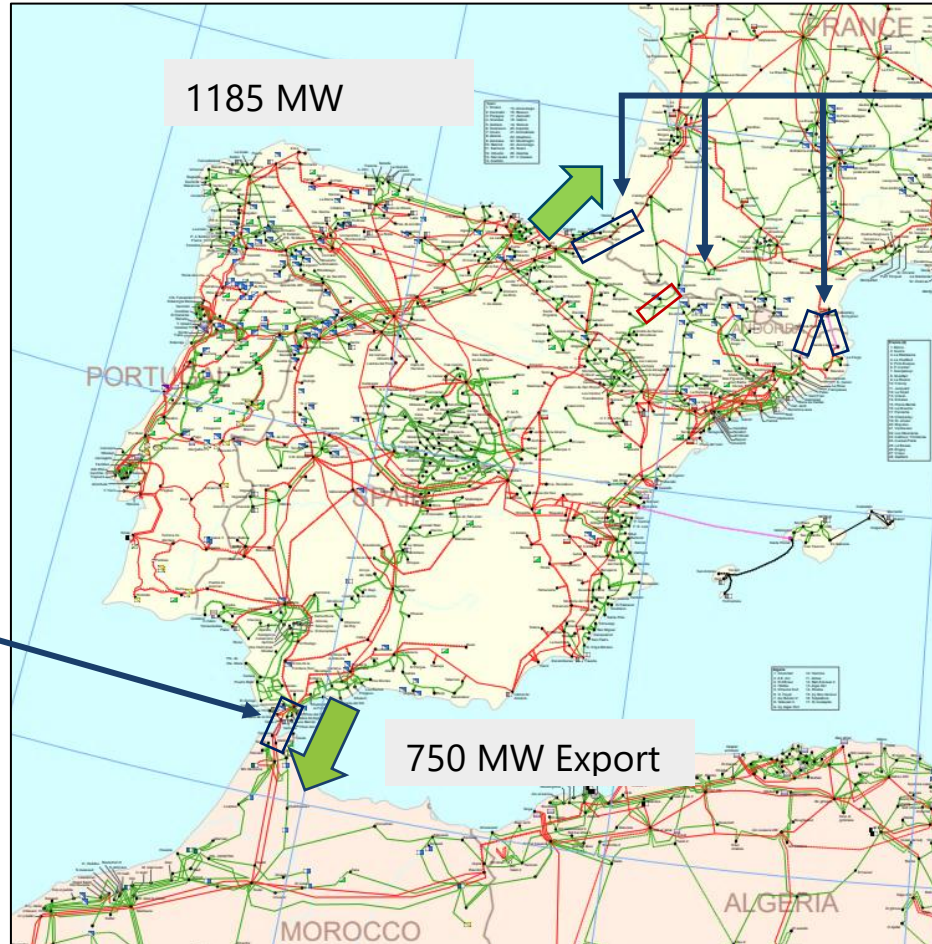
- 2x 400kV AC, 2x 220 kV AC,
- 1 HVDC.
- 2800 MW total capacity.
- 1 of the 220 kV lines (in red) was on planned outage prior to the blackout.

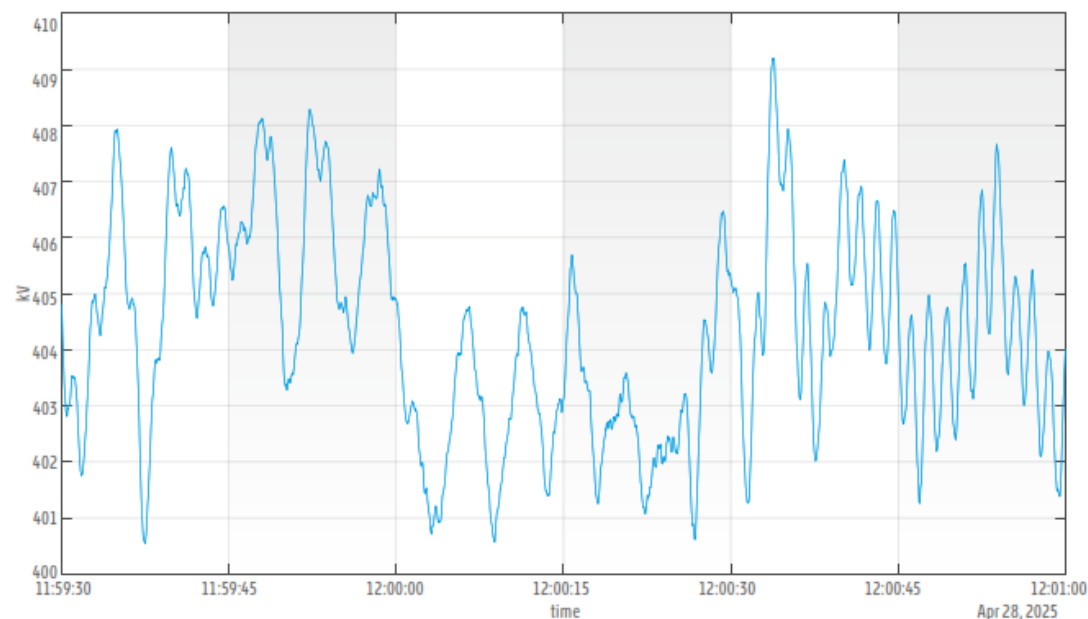
- 0.63 Hz oscillations in frequency and voltage in the Iberian Peninsula system. These were analysed post-event and determined to be local oscillations, likely generated from a control system injecting a periodic disturbance.
- A second 0.21 Hz oscillation 12 minutes later, corresponding to a known European inter-area mode, involving groups of generators.

0.63 Hz voltage oscillations prior to the event.
Source: ENTSO-E final report

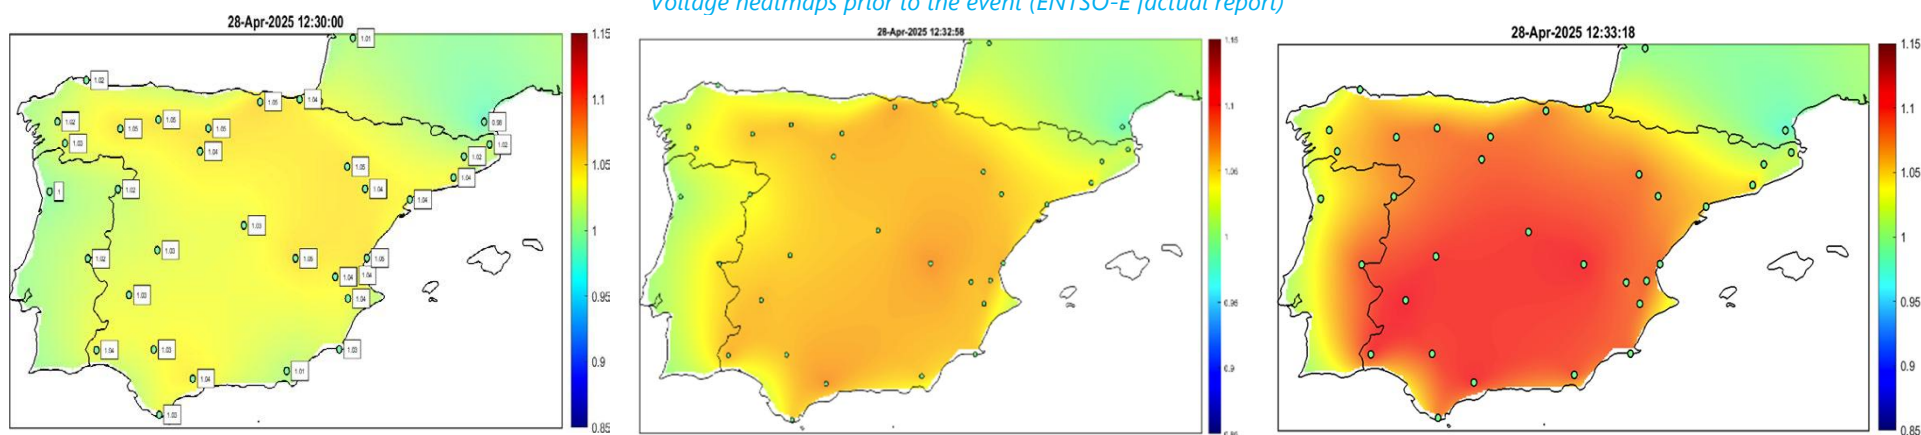
Voltage heatmaps prior to the event (ENTSO-E factual report)

As a result of actions taken to avoid oscillations, voltage began increasing. At 12:33, generation began tripping on over-voltage. Further generation tripping caused overvoltages over the next two minutes and the system collapsed.

- The first generation transformer tripped in Southern Spain on overvoltage while the grid voltage was still within limits, removing ~355 MW of generation. This had the effect of increasing voltage further by reducing reactive power absorption.
- A further 725 MW generation tripped in Southwest Spain, leading to even higher voltages.
- A further 1100 MW generation tripped around the south and southwest of Spain.
- Over-voltages from the loss of these generators caused cascade generation over-voltage tripping through Spain.
- Spanish/Portuguese AUFLS equivalent activated, but this was insufficient to prevent collapse of the system.
- The Iberian Peninsula was disconnected from the rest of the European grid by protection action on HVDC links and AC interconnections. Spain and Portugal power systems blacked out.
