## **4 September 2010 and 22 February 2011 Christchurch earthquakes from a transmission infrastructure perspective: asset structural performance and lessons learned**

Craig Mcghie, Transpower New Zealand Ltd.  
Christophe Tudo-Bornarel, Transpower New Zealand Ltd.

### **EEA Conference and Exhibition 2011, 23-24 June 2011, Auckland**

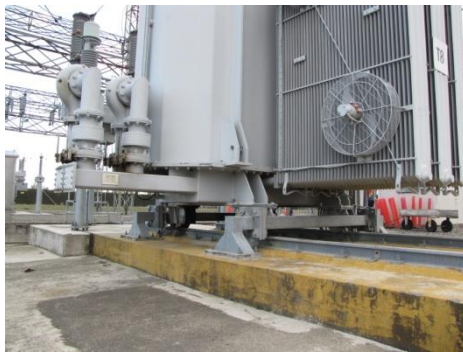
One of the lessons learned from the 1987 Edgecumbe earthquake was that transformers and heavy plant were at risk if not properly seismically restrained. A 10-year retrofit program was subsequently implemented to address the issue. The result of this earlier work is that the transformer banks had been retrofitted with seismic restraints and the restraints performed well during the 04 September 2010 and 22 February 2011 earthquakes, as shown in Figure 3 below.

(a) Hororata Substation: transformer banks retrofitted with proper seismic restraints performed well

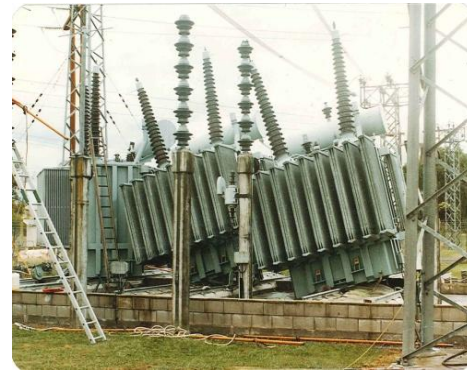
(b) Edgecumbe substation after the 1987 Edgecumbe earthquake: transformers were not seismically restrained and toppled off their pedestal.

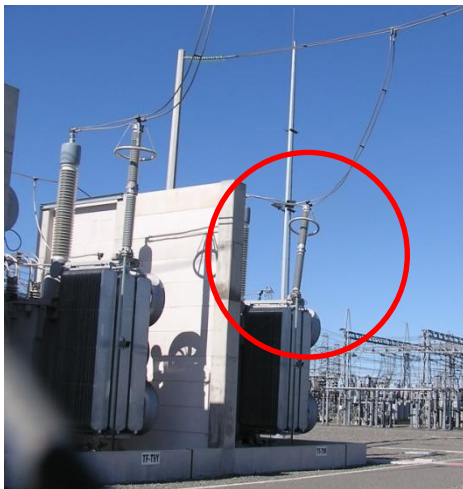
(a) overview of the SVC transformer banks

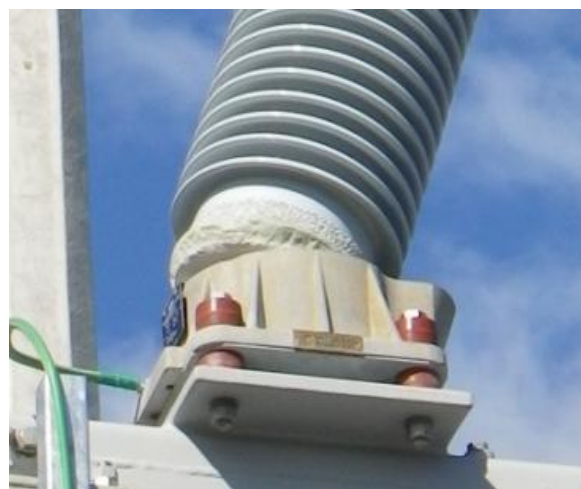
A surge arrester mounted on the SVC9 red phase transformer at Islington was damaged. The failure of the surge arrester did not result in an immediate outage even though the porcelain housing had cracked at the base, as shown below in Figure 4. Only very minor superficial cracking damage occurred to the reinforced concrete buildings at the substation.

(b) close-up on the surge arrester that failed.

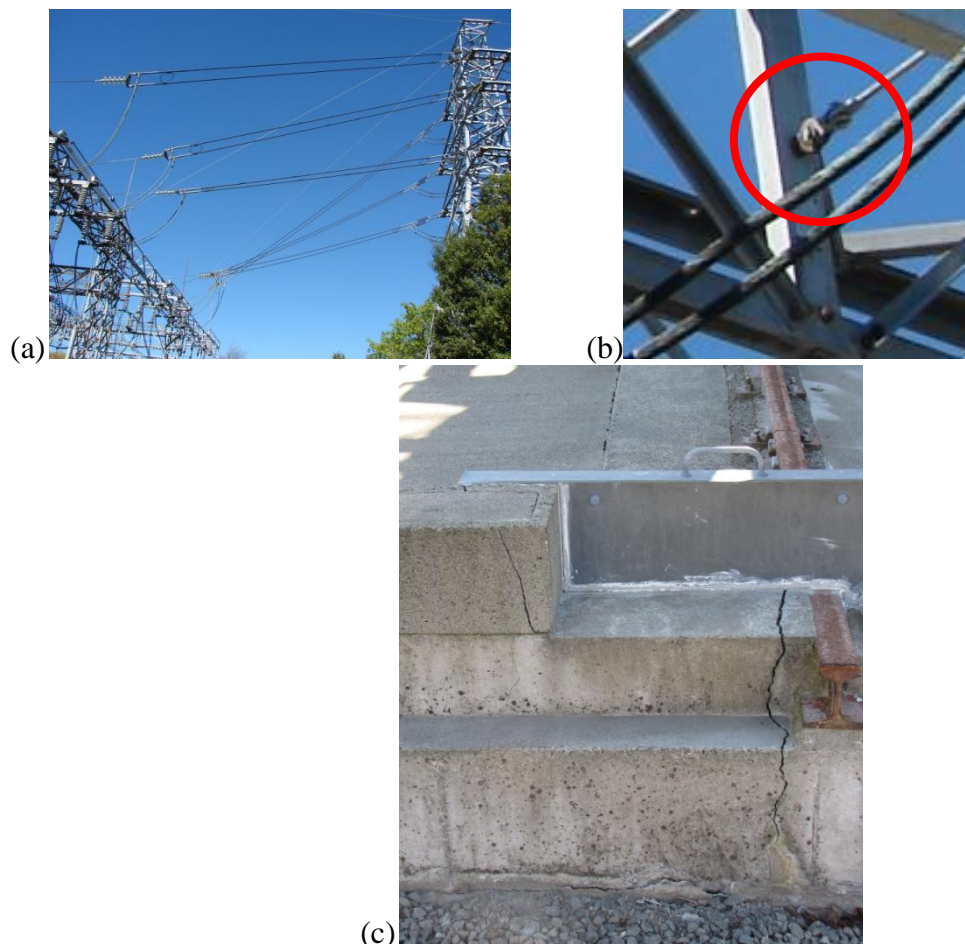
The southern end of the switchyard was affected by liquefaction following the 4 September 2010 earthquake. Settlement resulting from the liquefaction damaged the oil containment bund to transformer T4 as shown in Figure 5 below. The foundations of the terminal towers on both ISL-PAP A&B 66kV lines were strengthened in 2008 with the addition of 20m deep steel screw piles. Although the liquefaction around the tower foundations was extensive there was no discernable damage to the foundations.

Failure of the eyebolt attaching the red phase of the terminal span of the ISL-PAP B 66 kV transmission line circuit 4 to the substation gantry structure caused a fault as the conductor fell down onto another phase. The shortness of the terminal span (15m) and tightness of the conductors to achieve clearance contributed to the failure. The eyebolt was subsequently replaced by a spring bolt as shown in the photo below.

**Figure 5: Papanui Substation (Photos: Transpower)**  
**(a) termination span; cct1 is in the foreground, cct3 and cct4 are in the background**  
**(b) eye nut attachment to gantry identical to the one that failed**  
**(c) T4 bund cracked due to differential settlement.**

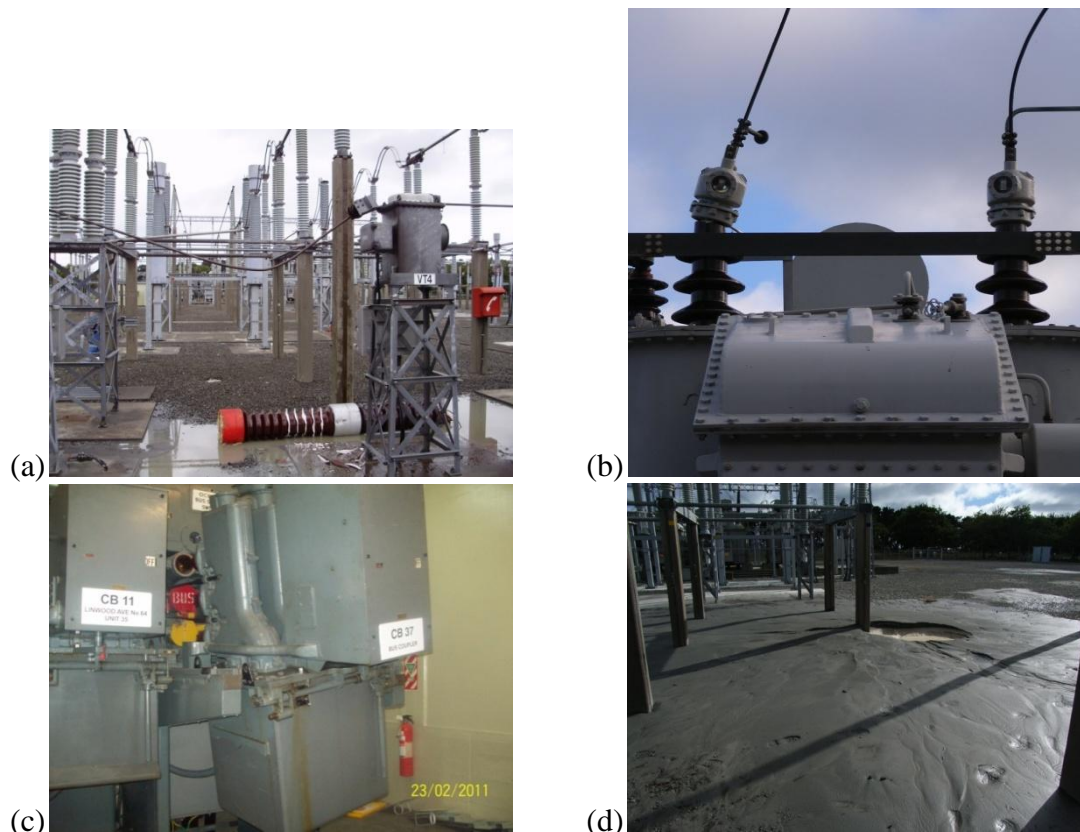
**Figure 6: Bromley Substation (Photos: Transpower)**

Bromley substation sustained negligible structural damage and minor soil liquefaction during the 4 September 2010 earthquake. However, located only 5km from the 22 February 2011 earthquake epicentre, the substation suffered structural damage to 4 items of equipment due to intense ground shaking, as shown in Figure 6 below. The 220kV CVT and 66kV bushings were replaced with spares. A new 11kV switchgear building is to be constructed, to enable replacement of the existing damaged but serviceable switchgear. The damage at Bromley did not prevent supply of power, but did reduce the system to n security until the CVT was replaced.

The switchyard was affected by intense liquefaction effects without apparent damage to equipment foundations.

**(a) 220 kV failed current voltage transformer**

**(b) failed 66 kV transformer bushing, snapped at its top**

**(c) damage to a 11 kV switch board with hold-down bolts pulled out of concrete; the switchgear remained operational during and after the earthquake**

**(d) severe liquefaction in switchyard with silt, sand and water erupting from ground; this did not cause significant damage to switchyard foundations.**

At Bromley no damage to the buildings was sustained and, as described above, some switchyard equipment failed. Spares were available and the failed equipment was replaced promptly which is tolerated by Transpower policy for ULS events. Equipment failures reduced the security contingency to n instead of n-1; again that is tolerated by the seismic policy. Hence buildings and equipment met the current performance criteria at ultimate limit state level.

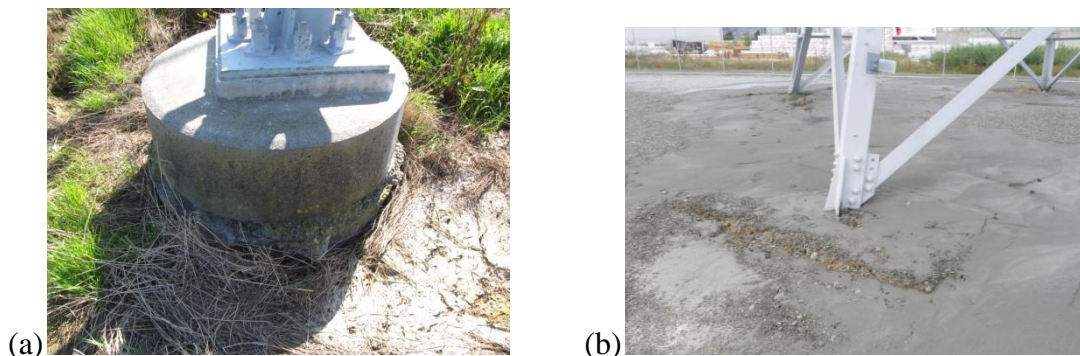
**Figure 7: Bromley-Islington A line (Photos: Transpower)**

Following the 4 September 2010 earthquake extensive liquefaction occurred in the area between towers 44 and 64 causing differential settlement of tower footings resulting in tilting of towers 44, 53 and 54. Tower 44 was temporary guyed to concrete blocks; no other immediate actions were required. Intense liquefaction also occurred following the 22 February 2011 at towers 1, 2 (close to Bromley substation) and Tower 11 without causing apparent damage. Refer to Figure 7 below.

**(a) Tower 44 with liquefaction leaving gaps around footings - 4 September 2010 earthquake**

**(b) Tower 1 with effects of liquefaction: ejected silt and soil settlement – 22 February 2011 earthquake.**

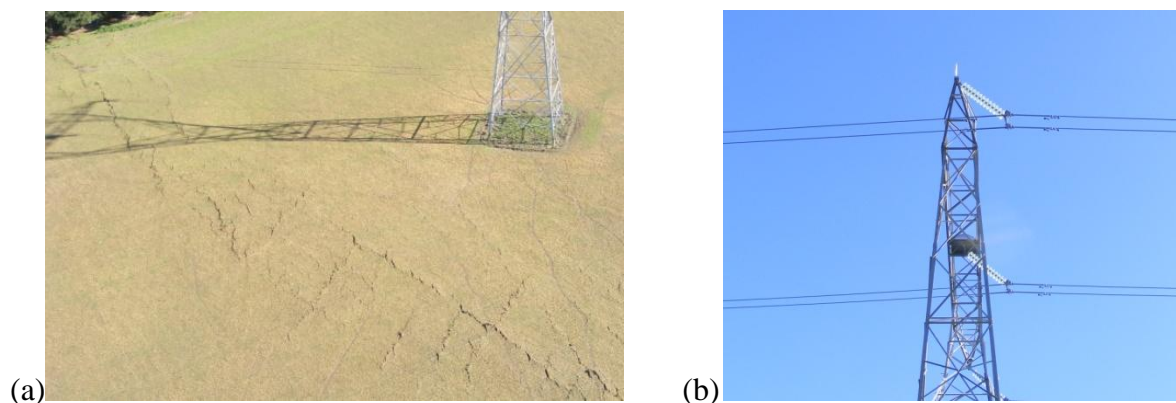
**Figure 8: Roxburgh-Islington A line**

**(a) Surface rupture passing at short distance from tower A1022 (courtesy of GNS)**

**(b) Misaligned suspension insulators at tower A1022 (Photos: Transpower).**

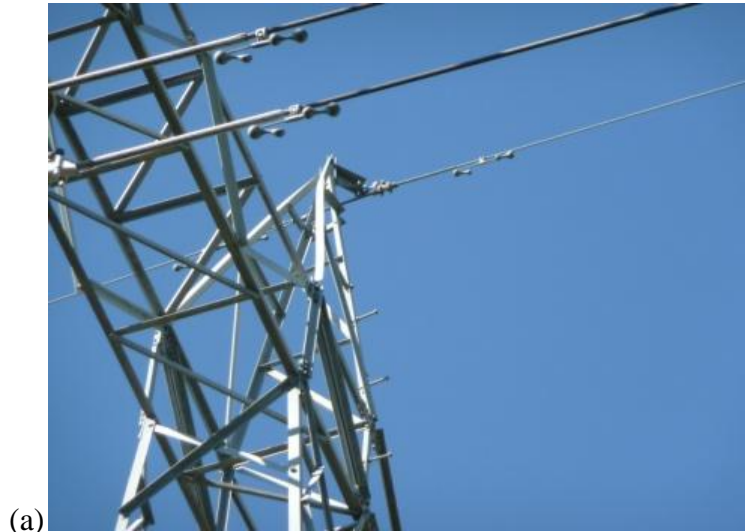
Refer to Figure 8 above for examples of ground rupture and insulator swing. In addition, towers 600 and 601 on the BEN-ISL A line sustained structural damage in the form of bent earth peaks as shown in Figure 9 and will need to be repaired. The damage did not affect the performance of the lines and did not require immediate actions. The insulators shall be re-clipped in the vertical position following cessation of the aftershocks, subject to confirmation of acceptable conductor tensions.

[Figure 9: Benmore-Islington A line \(Photos: Transpower\)](#)  
[\(a\) Earth peak bent on tower 600.](#)

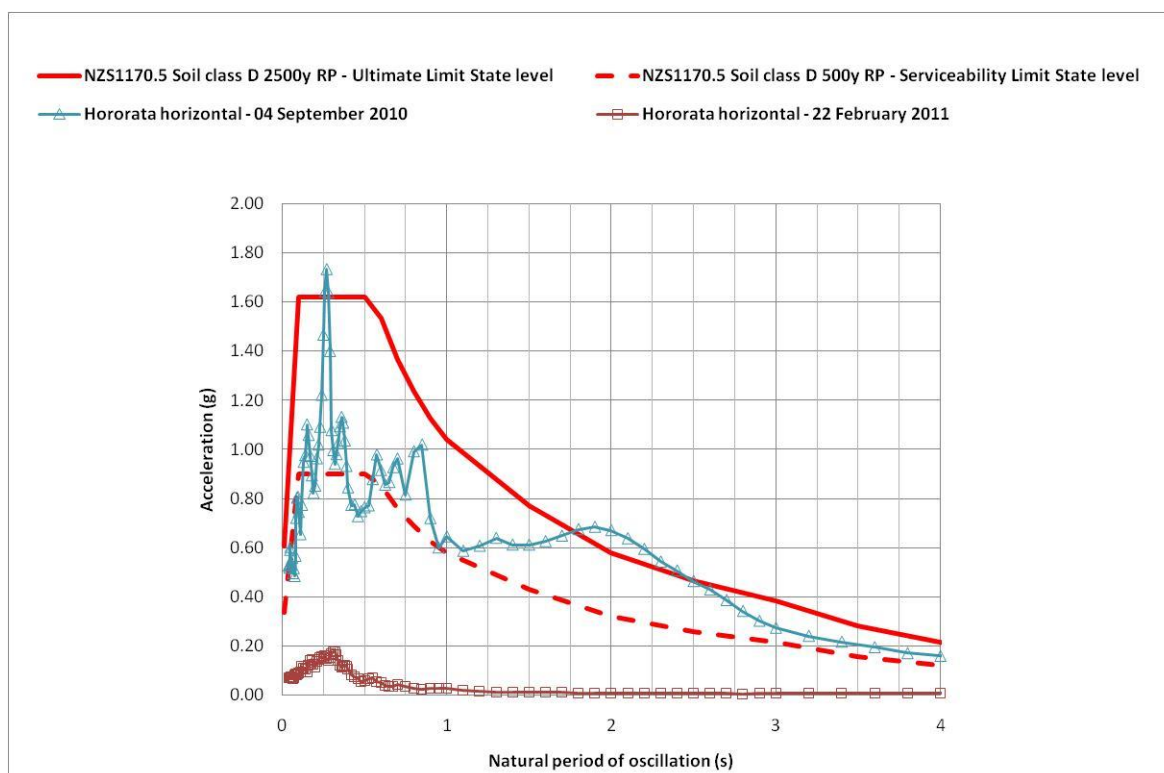
Hororata, the nearest substation from the 4 September 2010 epicentre (15km), experienced strong horizontal and vertical ground shaking. From GNS recordings at Hororata School the earthquake response spectra<sup>5</sup> correspond approximately to 75% of Transpower's current Ultimate Limit State level (return period 2500 years) for the 0.0 to 0.3s period range where most of substation structure and equipment fall, see Figure 10 below. Only minor damage to the building was sustained. There was no equipment failure. Hence, the building and equipment met the current performance criteria. The ground shaking at Hororata resulting from the 22 February 2011 earthquake was well below the SLS level earthquake as shown in the spectral response, Figure 10 below, and as such no damage was sustained.

**Figure 10: 4 September 2010 and 22 February 2011 earthquakes - Hororata substation. Response spectra at 5% of critical damping (from GNS) compared with NZS1170.5 ULS and SLS requirements for the site**

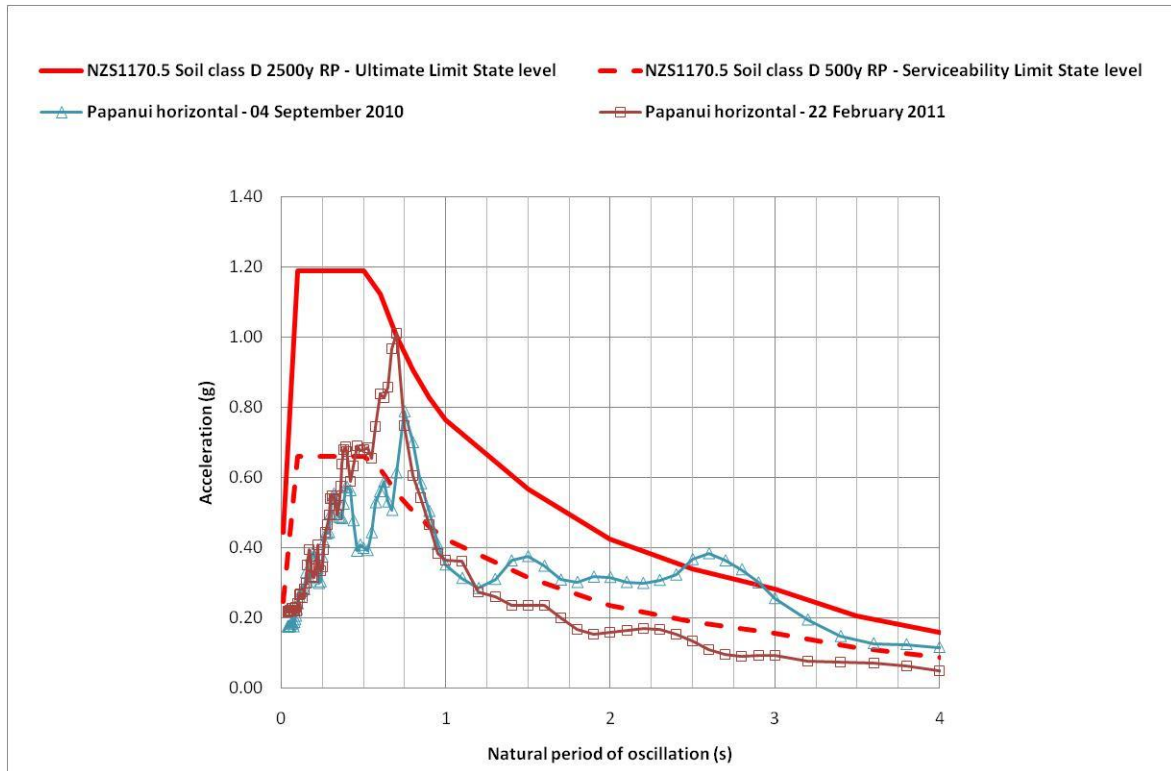
The substations closer to the CBD area during the 4 September 2010 earthquake or north and west from the CBD during the 22 February 2011 earthquake generally experienced shaking corresponding to Transpower’s current Serviceability Limit State level (return period 500 years) for the 0.0 to 0.3s period range. The Figures 11 and 12 below shows the response spectra at Papanui substation (4km north of the CBD) and Bromley substation (5km east of the CBD) for both earthquakes respectively. Although not necessarily designed for this level of earthquake loading, the substations structures and equipment performed well and met the current performance criteria at serviceability limit state level with the exception of the terminal span failure at Papanui substation and the 220kV surge arrester failure at Islington during the 4 September 2010 earthquake.

[Figure 11: 4 September 2010 and 22 February 2011 earthquakes - Papanui Substation. Response spectra at 5% of critical damping \(from GNS\) compared with NZS1170.5 ULS and SLS requirements for the site](#)

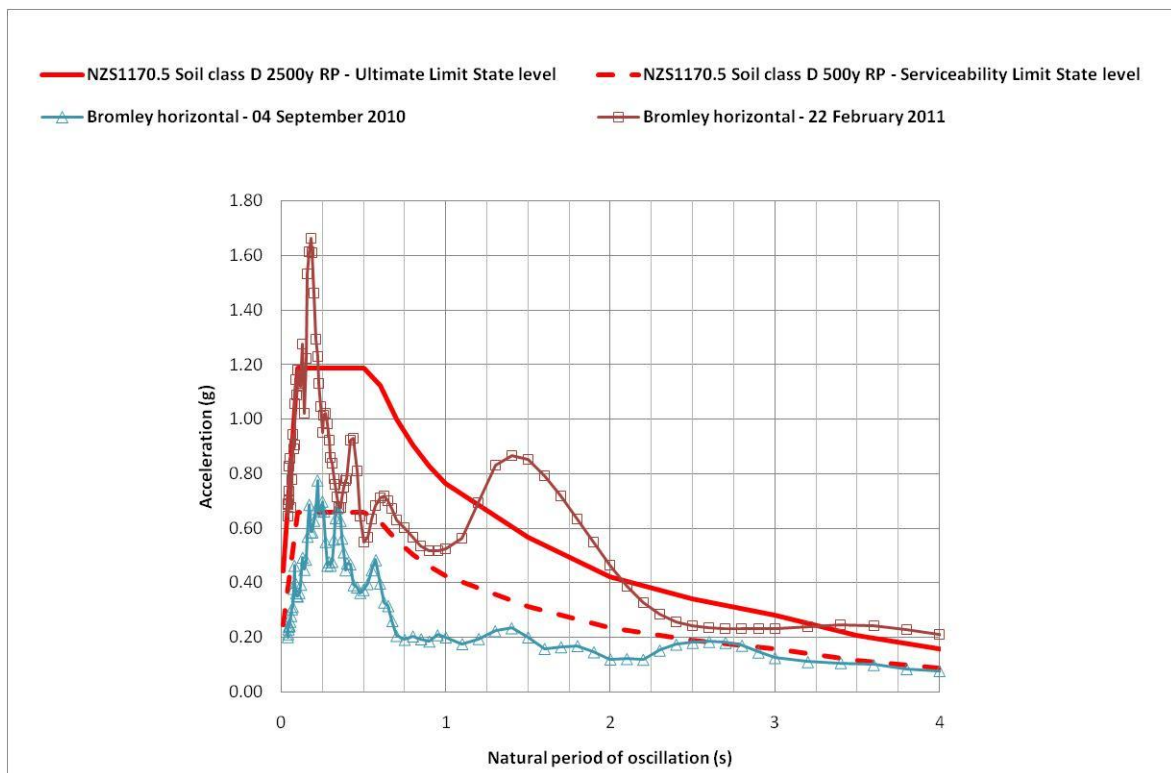
However, Bromley, the nearest substation from the 22 February 2011 earthquake epicentre (5km), experienced very strong horizontal and vertical ground shaking. GNS recordings at Pages Road pumping station (1.5km from Bromley substation with same ground conditions) provide a good indication of the level of acceleration experienced at the substation. The earthquake response spectra correspond to Transpower’s current Ultimate Limit State level (return period 2500 year) for the 0.0 to 0.3s period range, refer Figure 12 below.

[Figure 12: 4 September 2010 and 22 February 2011 earthquakes - Bromley substation. Response spectra at 5% of critical damping \(from GNS\) compared with NZS1170.5 ULS and SLS requirements for the site](#)
