UPPER SOUTH ISLAND RELIABILITY STAGE 1

ATTACHMENT E ISLINGTON SUBSTATION HILP EVENT STUDY

Transpower New Zealand Limited
May 2012

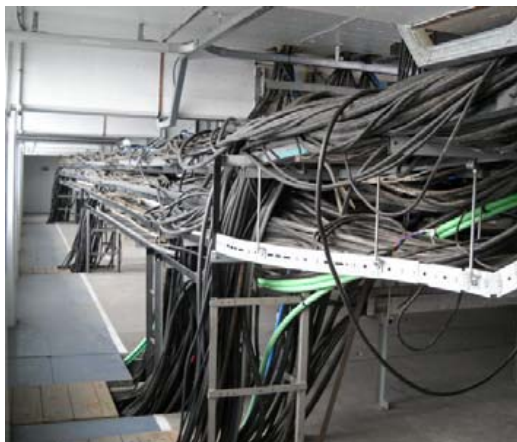
The consequences of a major fire in the cable basement could be catastrophic, potentially leading to loss of supply or severe rationing of supply to large parts of Christchurch and the upper South Island.

ISL cable basement – general view

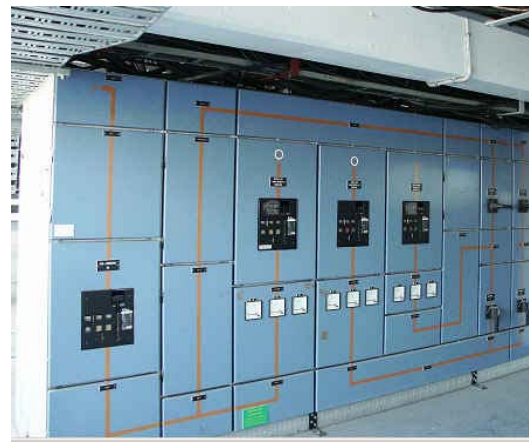
Main 415 V LVAC switchboard

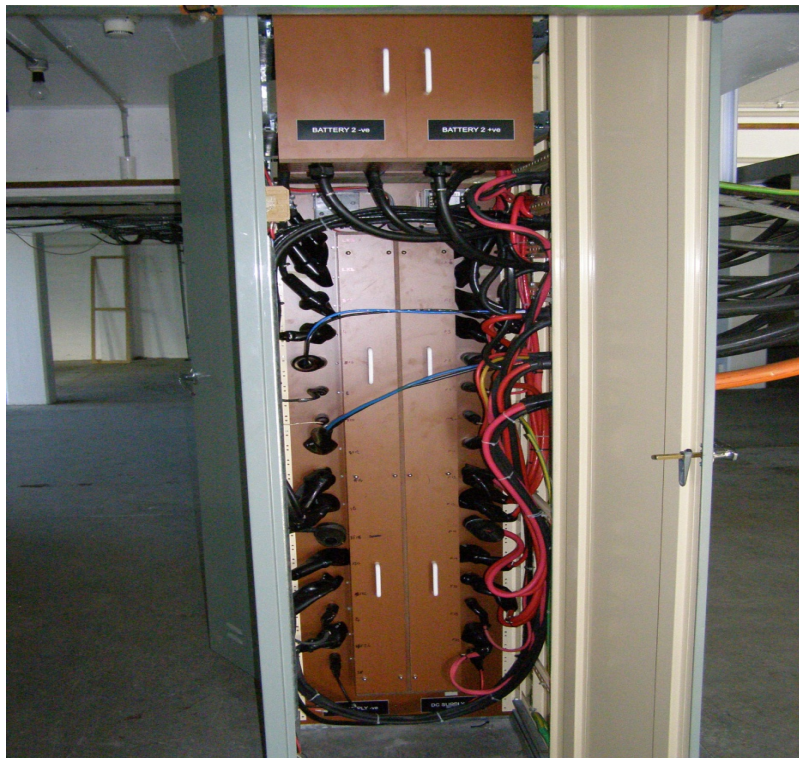
Main 110 V dc distribution panel

The most critical of these is the 110 V dc system, because failure would immediately disable all switchgear protection and control. Transpower has no standard procedure for dealing with total loss of 110 V dc, and response would be slow and difficult.

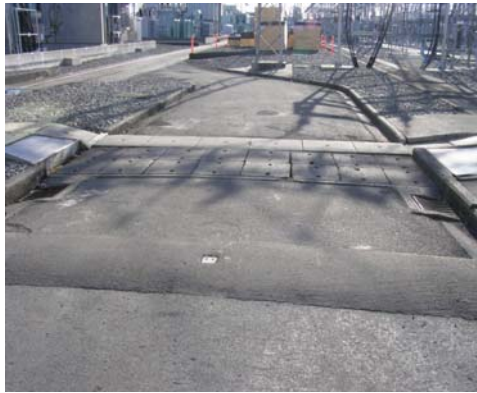
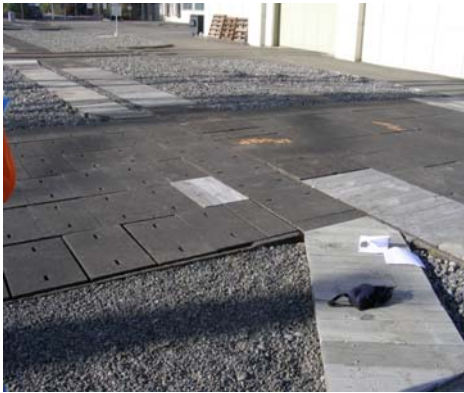
<p>All control and protection cables, from the 220 kV switchyard, are installed in these trenches beneath the main access route into the switchyard. There is a further crossing at the apron in front of the control building.</p>	<p>All control and protection cables, from the 220 kV switchyard, appear to cross 11 kV heavy power cable runs at this point. Details of cross-over to be photographed separately.</p>

The cable trenches crossing the main vehicle access route into the switchyard are densely packed with cables, and appear vulnerable to impact damage from above.

The crossovers of control and 11 kV power cables represent a potential point of major failure in the event of a power cable fire. Details of the crossover have not yet been obtained.
