## Low Voltage Electric Shock

A tradesperson and an apprentice were attempting to identify a low voltage 230v a.c. circuit in a Gas Insulated Switch room basement.

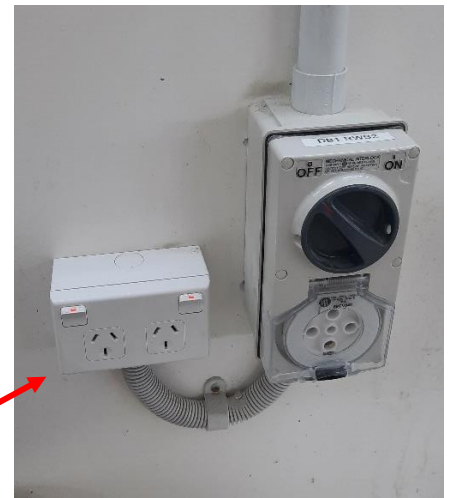
The apprentice applied multi-meter probes to the back of the single-phase wall socket outlet that had been pulled out from the wall.

Once satisfied that the socket was de-energised, the apprentice touched the back of the socket and received an electrical shock to their right hand.

Faceplate taken off and multimeter test probes applied to test for voltage.

- Checked that the apprentice was feeling well.
- Checked the plug socket outlet for voltage and found to still be alive.
- Temporarily isolated the circuit.
- Arranged an ECG from the local emergency centre doctor.
- Reported the incident to management.
- Organised drug and alcohol testing for the tradesperson and apprentice.
- Notified Worksafe
- An investigation is now underway.
