Capacitor Bank Insulator Failure

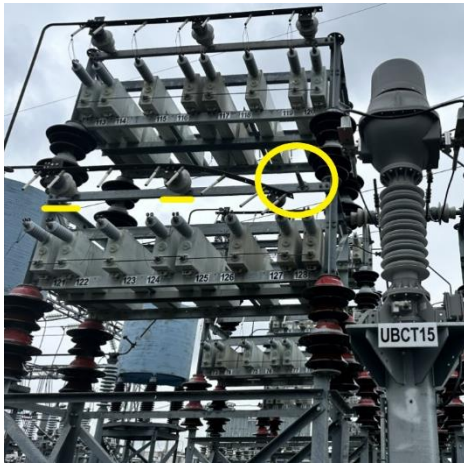
On Friday 3rd November at 12:19pm, there was a loud bang heard in Islington (ISL) switchyard. Upon investigation, it was identified that ISL Capacitor bank 15 had tripped and one insulator failed resulting in porcelain insulator pieces exploding and scattering over the surrounding area with the potential to cause harm.

Figure 1. ISL C15 Blown Insulator and fuses

- Identified no personnel on site were harmed as a result of the exploding insulator and there was no damage to the surrounding assets.
- The capacitor bank was isolated and earthed by the service provider and made safe so a closer visual investigation could be carried out.

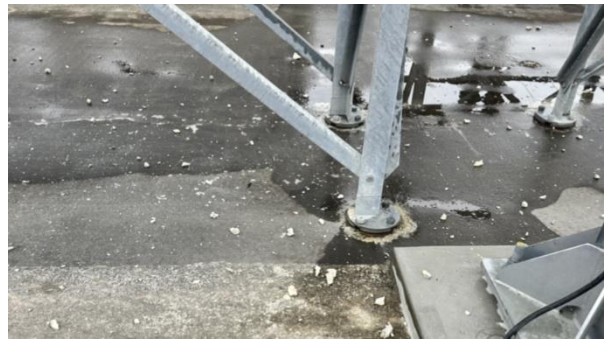
Figure 2. Insulator pieces on the ground
