## Bullhorn (conductor catcher) Degraded

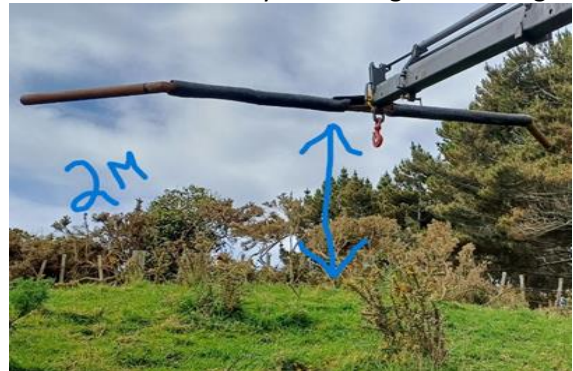
While the Hi-ab crane operator was using his remote control to raise the bullhorn, it failed when it was approximately 2 metres from the ground. The bullhorn was positioned at the rear of a crane truck, connected to the crane's Hi-ab extension arm. The surrounding area was cordoned off, and no one was inside this exclusion zone when the bullhorn failed.

The bullhorn structure was not certified or rated. Pre-use visual inspections were not sufficient to verify the strength and integrity of the equipment.

The height at which the Bullhorn failed and dropped to the ground

Ensure all relevant rigging equipment is certified and or rated correctly and scheduled inspections take place.

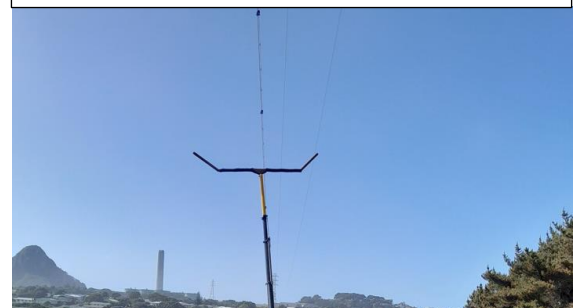
Bullhorn in operation
