Alert

Health Safety Environment

14/03/2024

Incident date: 29.02.2024

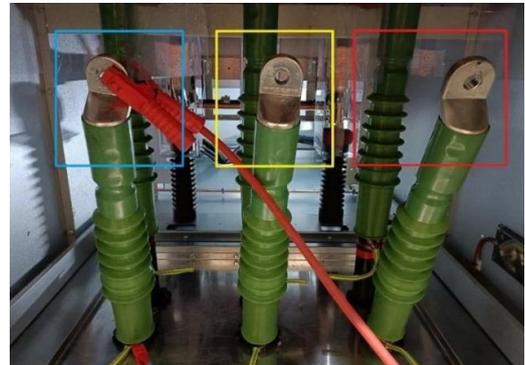
- After a Downer project team had performed Very-Low Frequency (VLF) cable testing, third party contractor entered the work area and touched a discharged cable, receiving a shock.
- The VLF testing had been completed as per procedure and verbal confirmation of cable discharge was given to the third-party contractor.
- Integrity checks on the station earth grid and test equipment have ruled these out as contributing to the incident.

- Capacitive coupling can cause a transfer of energy to un-earthed cables in the vicinity of VLF testing. The project team believe this has related directly to this incident.
- The risk of capacitive coupling can be significantly reduced by following Earthed working procedures.
- When contacting cables, a test before touch approach should always be completed by the individual to ensure safety before access.

All Downer procedures relating to VLF testing are being updated to include:

1. All permanent earthing must be completed before VLF testing begins, and all cables in the vicinity of the VLF testing must be earthed before commencing testing.
2. Before commencing VLF testing, all adjacent cables will have their phase conductors earthed.
3. Insulated HV gloves must be used to provide protection against shocks and must be worn to swap test and bonding leads.
