TRANSPOWER

# HVDC Link Upgrade Programme Major Capex Proposal (Stage 1)

Attachment 3: Cable Condition Assessment Report

September 2025

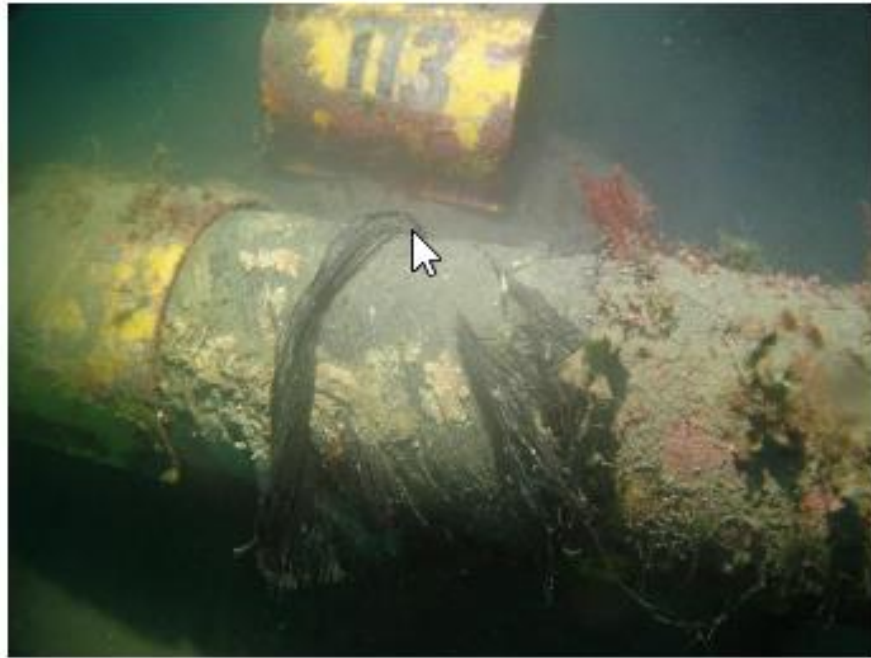
1. KP 0.567-0.577 – from Scuba report 2021. Armour exposure to underside of cable.

Figure 4: Armour exposure to underside of HVDC#4 KP0.575 beneath clip 113.

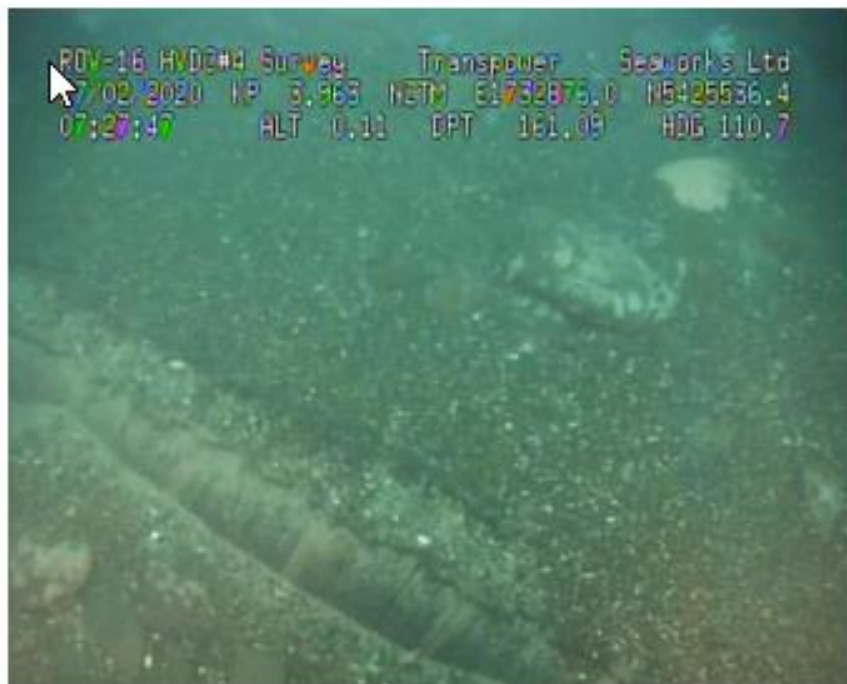
2. KP 3.950 – 3.970 – from ROV report 2020. Wide pattern of sliding contact damage from contact with FO9 applying downward pressure on crown of cable 4.

Figure 4: Serving damage - wide pattern KP3.963

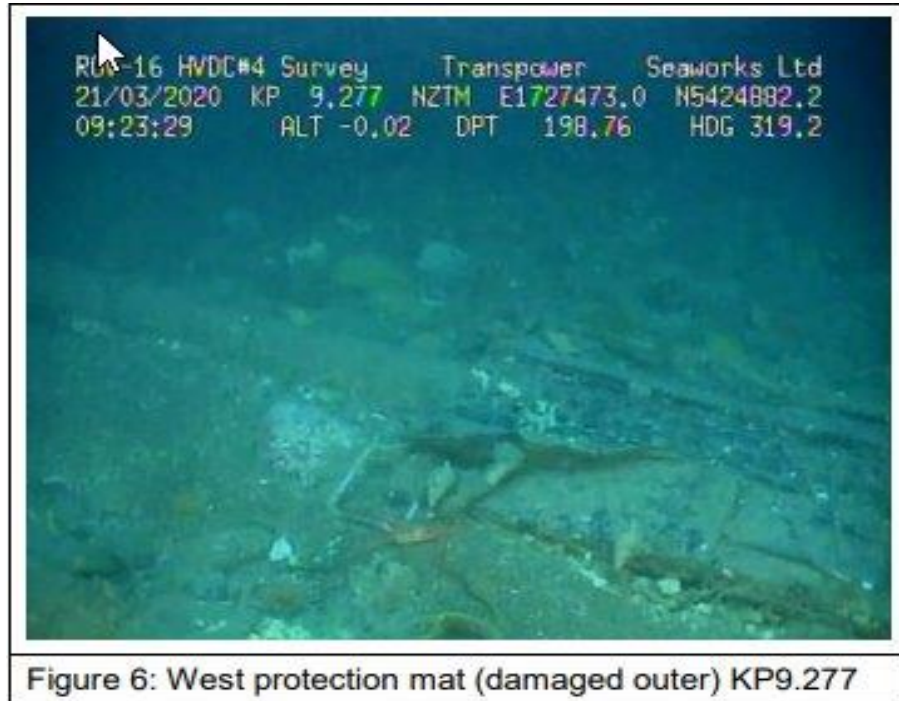
3. KP 9.274 – 9.278 – from ROV report 2020. This has been downgraded to a minor defect but is something to note. Protection mats installed to cover bare armour.

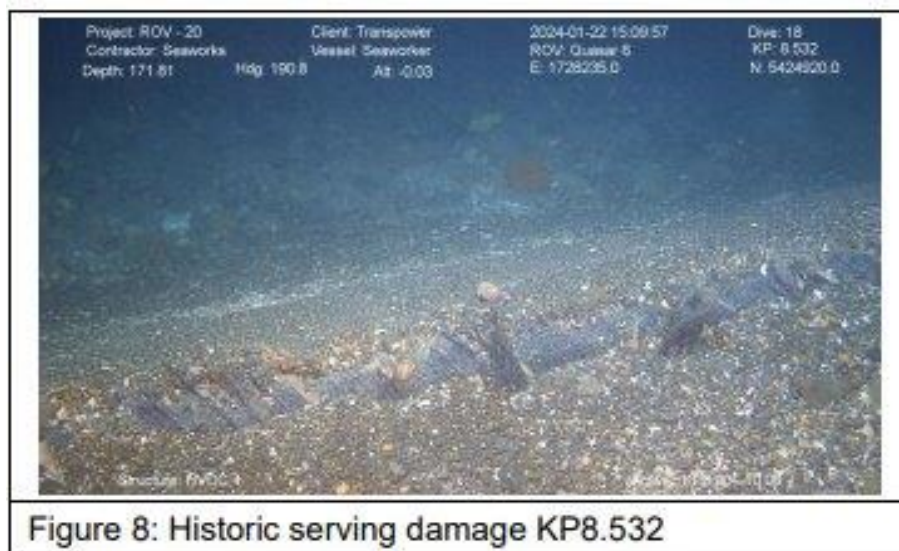
4. KP 8.532 – from ROV report 2024. Shows historic serving damage on HVDC cable 4.

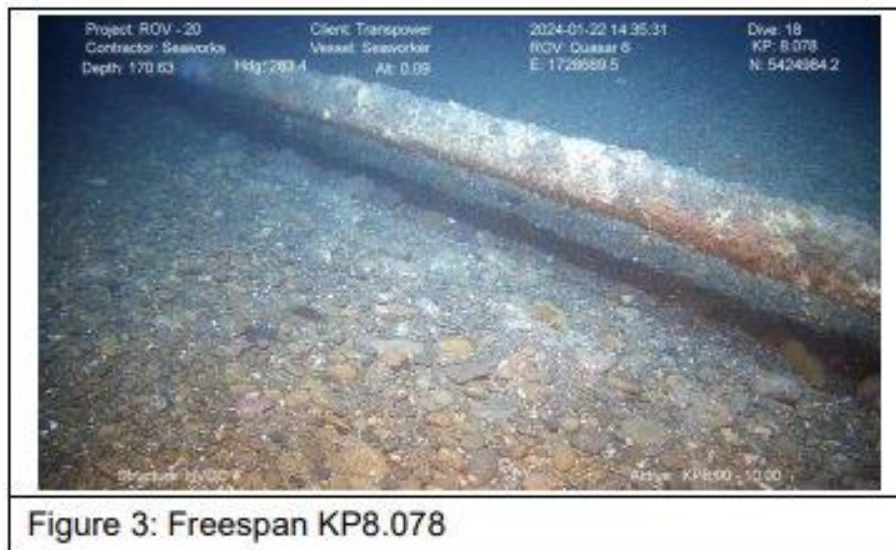
5. KP 8.078 – from ROV report 2024. Shows the cable in freespan, 8m in length.

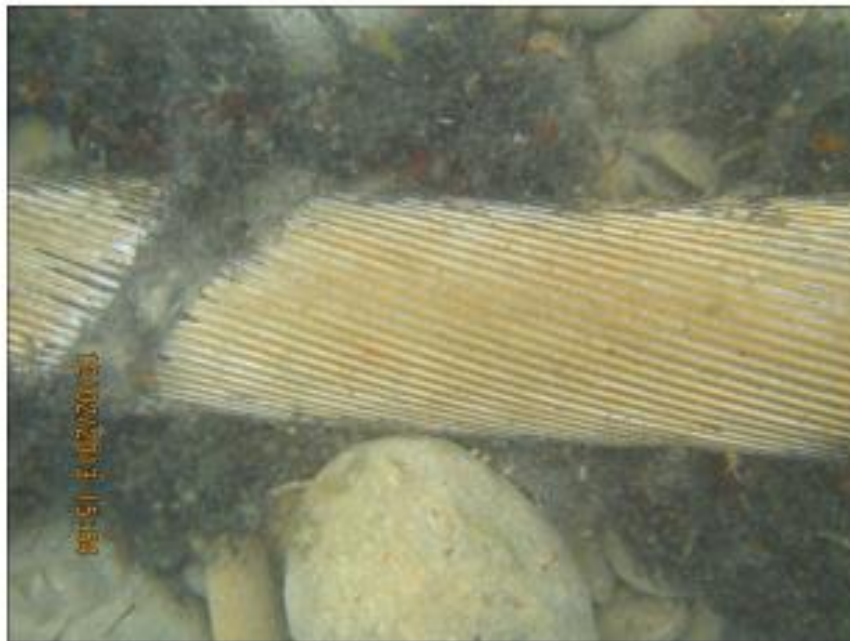
6. KP 0.106 – from Scuba report 2015. 9m extensive serving damage and 3m of exposed armour. Burial has since prevented inspection during dive surveys.

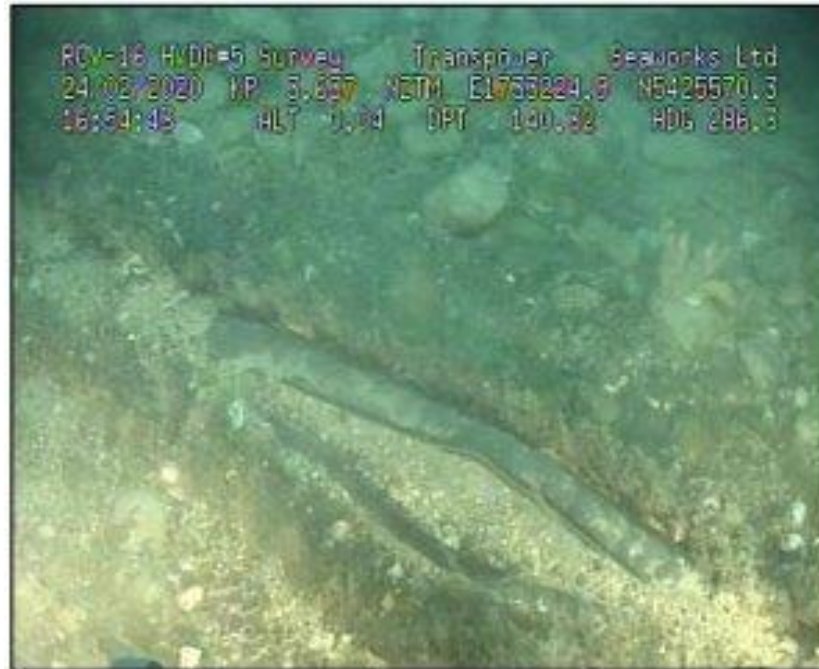
1. Major Defect at KP 3.637 – from ROV report 2020. Area of most severe damage, rupture of serving and wear sleeve, caused by sliding contact abrasion of FO#9.

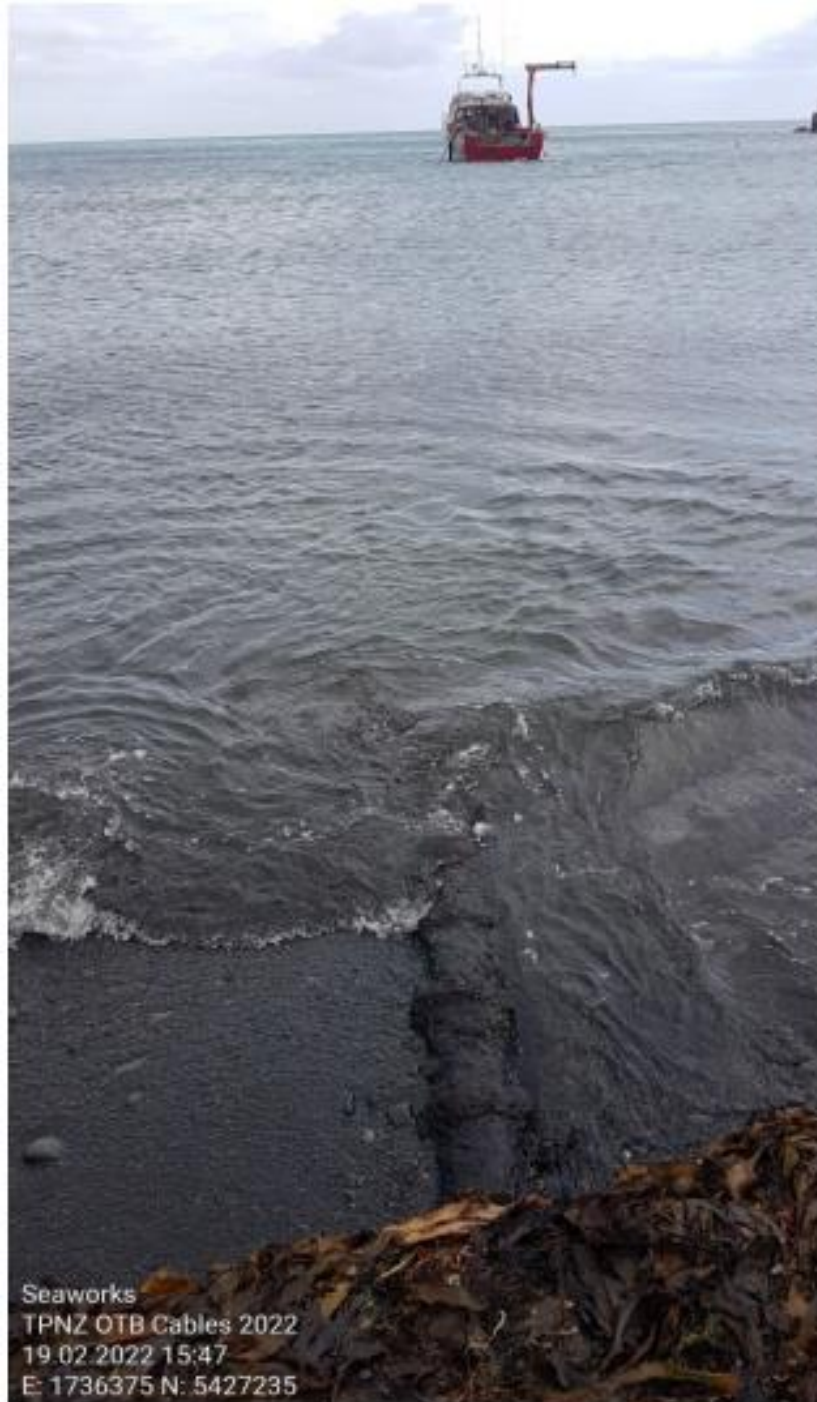
1. From Scuba report 2022. Cable 6 protected by split-pipe at shoreline.

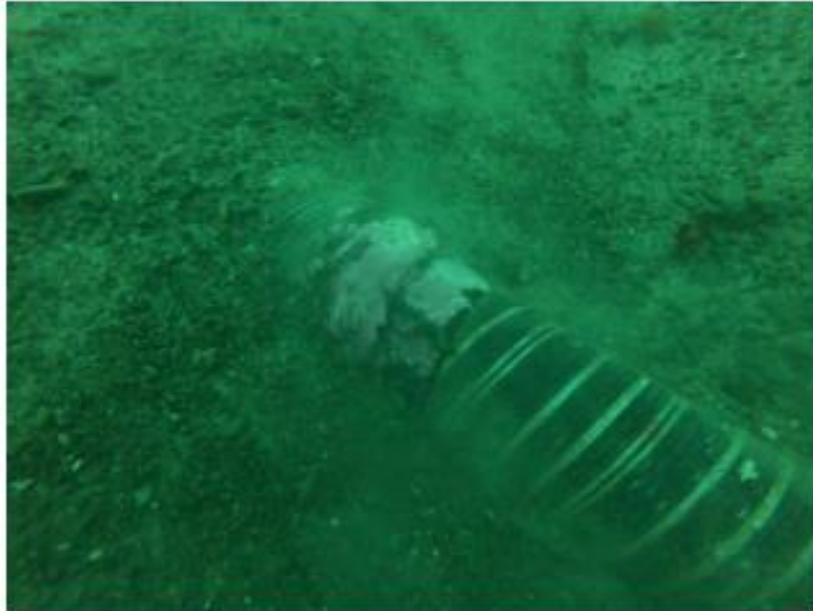
2. KP 1.116 – from Scuba report 2022. Cable with repair bandage.

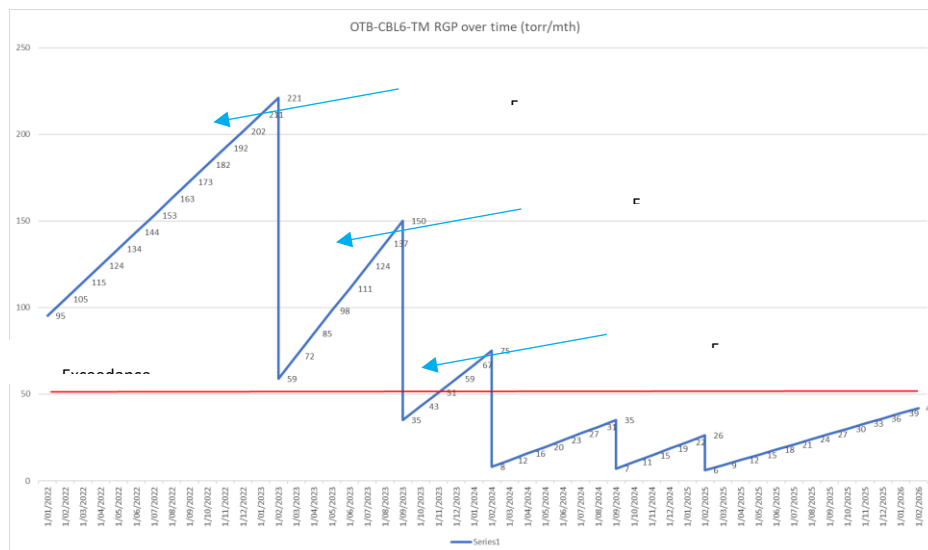
If a high RGP is detected action is recommended to be taken, as we are doing presently, essentially a flushing process. The RGP level for Oteranga Bay Cable 6 Termination is shown below with further predictions.

Given the level of nitrogen saturation, gas will continue to be released into the oil for some time. Periodic RGP or DGA measurements are taken (6 monthly) and if elevated levels are seen the sealing end is flushed under special circumstances.

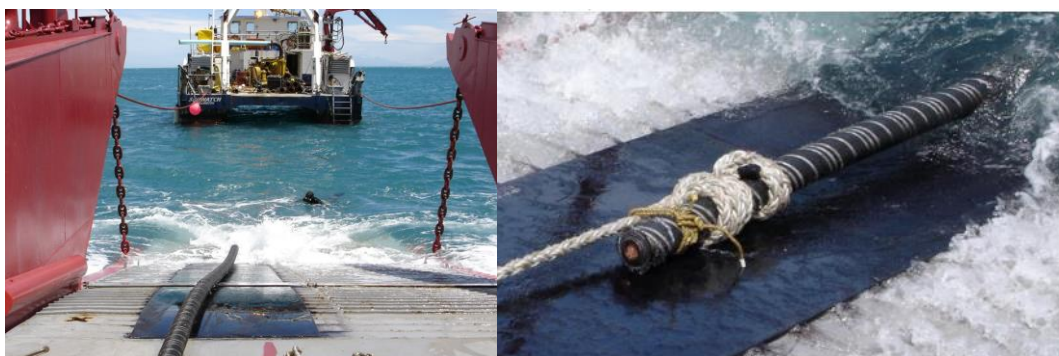
**Figure 2: Cable being hauled aboard during the cable repair at the OTB end in 2004**

An initial fault location was estimated using time domain reflectometry on 5 October. On 14 October 2004 a test set and divers were used to locate the fault at the seabed. The divers did report seeing many "white" bubbles rising to the surface but could not directly find the location. The third attempt on 6 November 2004 found the fault location at 345 m from the sealing end of Oteranga Bay, with a stream of very fine bubbles escaping between the servings wrapping the cable.

Initially a cut and cap of the cable was undertaken, this is to prevent water ingress further along the cable. Given the low depth of the fault (12m), Transpower (through Seaworks) sourced an ex-USA Navy tank landing barge, and then designed and constructed cable handling equipment and a relocatable cable jointing building on the barge.

During the initial repair, the first joint had to be redone due to emergency safety action. The safety action was to cut the deployment cables due to rough seas and 80kph winds. This resulted in a bending radius of 1.3m which was below approved specifications and hence a new joint required to remove the bent section. A repair joint was also required closer to the cable sealing end on land. This shows that even a repair in shallow water can prove to be difficult in Cook Strait. Any deeper repairs would require longer sections of cables that will be heavier and take up more space requiring bigger vessels that would need to be sourced from overseas. Overall cost of the repair in 2005 in shallow water was approximately \$13.5M. The repair took 168 days (nearly 6 months).
