TRANSPOWER

## Ōtāhuhu – Whakamaru A&B lines reconductoring – Auckland wider region section

Attachment 1: Condition Assessment Report

December 2025

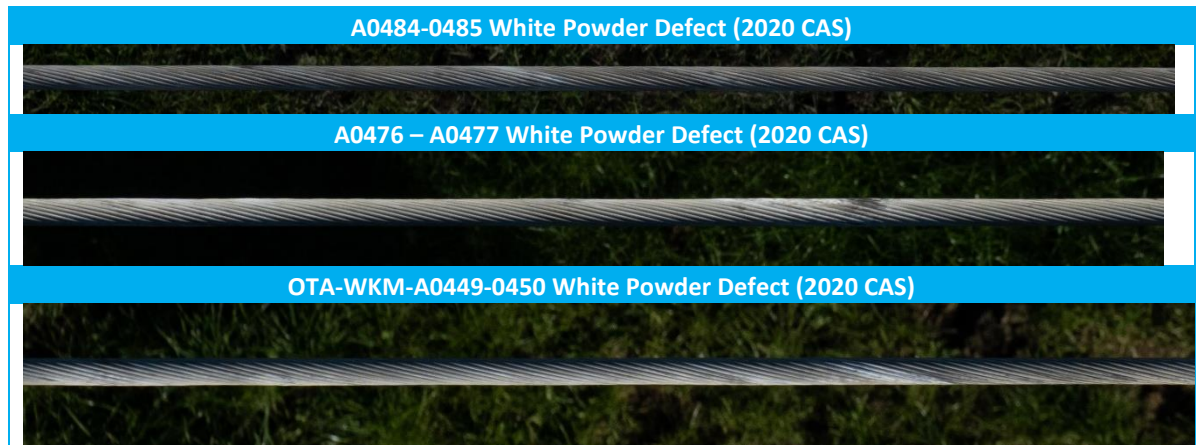
The Stage 2 segment of OTA–WKM–A, spanning T489 to T407, remains strung with the original 1952 Goat ACSR–GZ conductor. Our annual programme of CAS inspections using RPAS identified widespread white powder defects throughout the section of line. Examples of these defects are shown in Figure 3.

**Figure 3. Example of white powder defects found on the Stage 2 section of the OTA–WKM–A line**

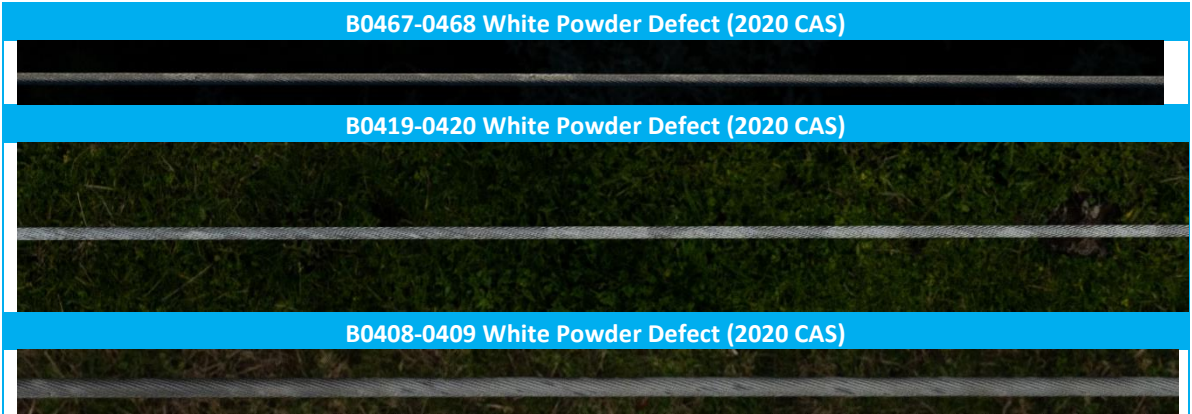
The Stage 2 section of OTA–WKM–B, from B0469 to B0391, is strung with the original 1954 Goat ACSR–GZ conductor. CAS inspections have identified widespread white powder defects throughout this section of line, examples of which are shown in Figure 4, indicating advanced corrosion of the steel core and sacrificing of aluminium cross-section.

Figure 4. Examples of white powder defects found on the Stage 2 section of the OTA–WKM–B line

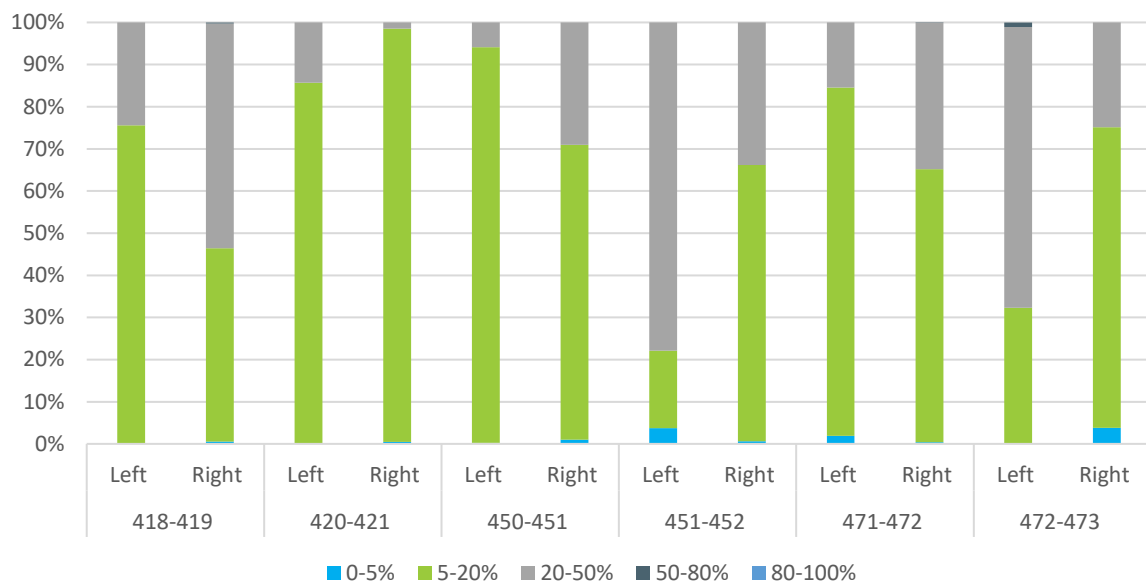
Figure 5 and Figure 6 show the estimated coating loss in spans which were included in the 2016 eddy-current testing programme. Overall, the OTA–WKM–A line has more advanced coating loss than the B line, including some localised areas of very high coating loss in spans 471-473 which could indicate grease defects. On both the OTA–WKM A&B lines, there were a few spans with widespread coating loss, such as the right phase of 430-431 on the B line and the left phase of 451-452 on the A line. As eddy-current testing is only performed on a handful of spans, there are likely a number of spans with similarly widespread coating loss.

**Figure 5. Estimated coating loss by span and phase (left or right) in Stage 2 section of the OTA-WKM-A line**

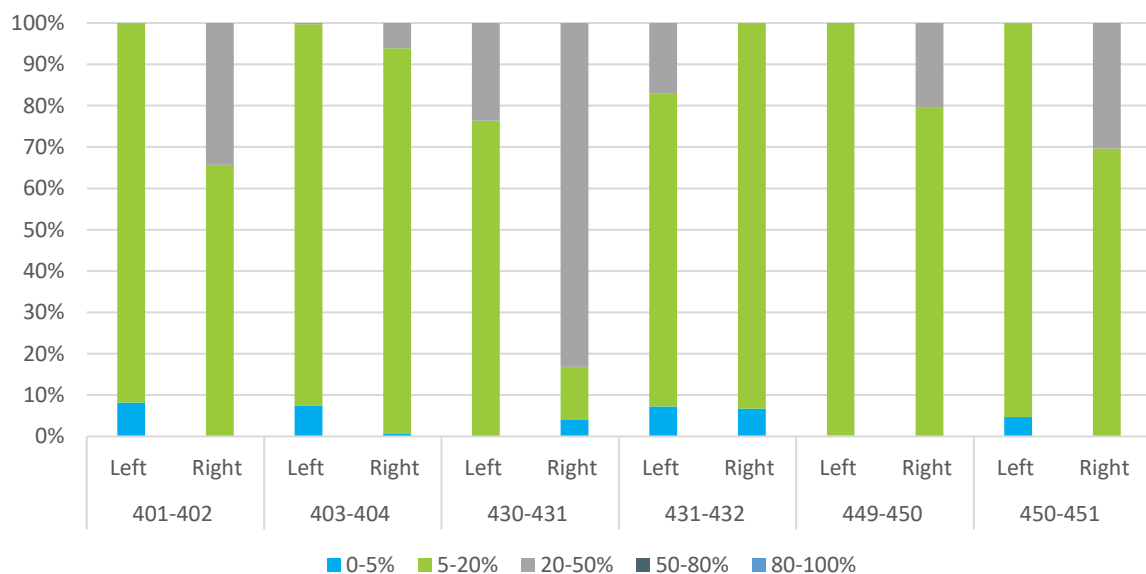
**Figure 6. Estimated coating loss by span and phase (left or right) in Stage 2 section of the OTA-WKM-B line**

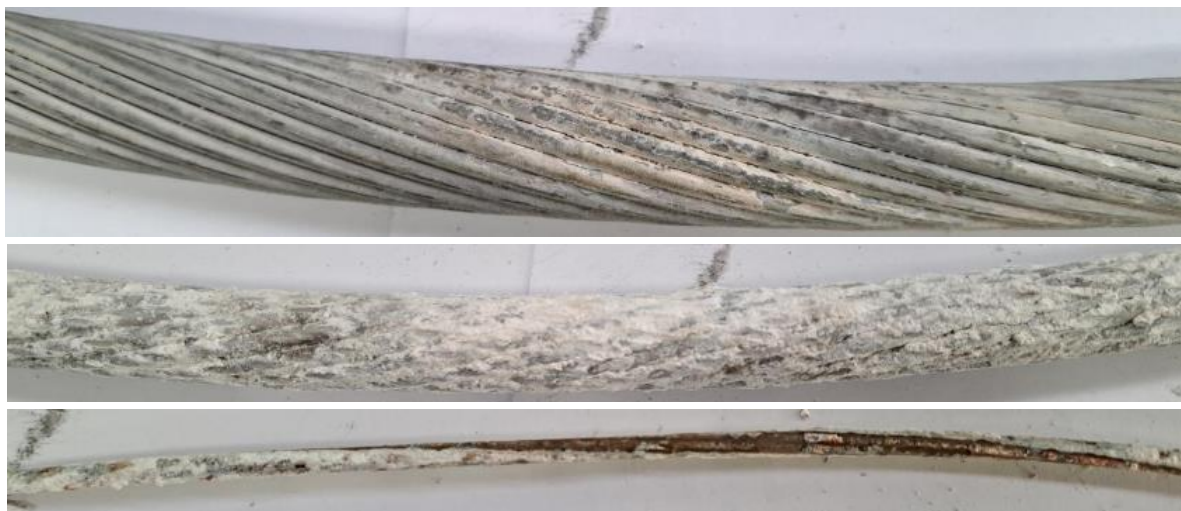
Figure 7 and Figure 8 show CAS images of two white powder defects which were cut from the line and sent for sampling in 2024. Overall, these samples had sufficient mechanical strength due to the high contribution of strength from the steel core, but the aluminium layers had significantly reduced breaking strength, indicating loss of section due to galvanic corrosion (Table 7). During testing, these two defects were confirmed as bulges; these had not been previously identified as such, either because they were small bulges which were misclassified during the CAS inspection, or because they developed to bulges since the CAS inspection. We were also able to see that the core steel had no galvanising along the length of the sample, as seen in Figure 9.

**Figure 9. From top to bottom: outer layer bulge, inner layer corrosion, and core steel corrosion in the A0386 – 0387 span**

Both samples retrieved from the Stage 3 section of the A line (Figure 7, Figure 8) had sacrificed the zinc galvanising layer on the core steel and galvanic corrosion had occurred between the steel and aluminium layers (Figure 9), resulting in reduced breaking load due to loss of aluminium cross section (Table 7). We consider these samples to be representative of the condition of the ungreaed conductor in the Stage 2 and 3 section of both lines, due to the proximity of the samples
