Bent Plate Loop Fall Arrest Attachment Point

Quality Alert REF No: 2024-003

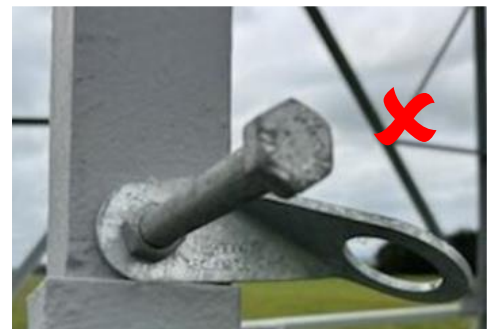
Issues encountered were BPLs:

- incorrectly torqued and tightened.
- installed beside splices when they should not have been.
- not having the zinc primer sealing around the plate interface on non-painted towers.

- Towers subjected to the same installation issues were identified.
- Towers were re-visited to inspect/correct any BPLs not complying with requirements.
- This alert is being sent to Service Providers and Job Managers to emphasize the importance of following Service Specifications and SMPs.
- Transpower is reviewing the use of Fall Arrest Attachment Points.

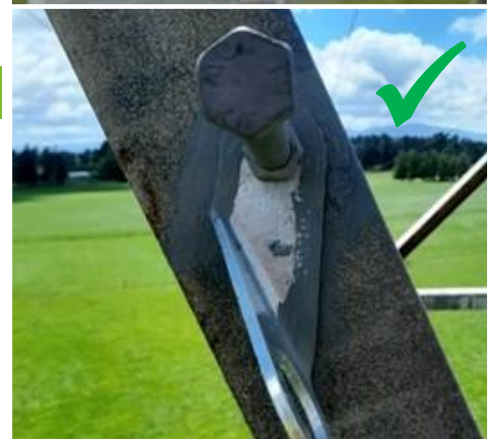
- It appears BPLs were not installed as per Transpower Service Specification TP.SS 02.98 Transmission Lines Asset Maintenance Requirements, and therefore needed further inspection before use.
- The BPLs were installed prior to the development of current best practices outlined in SMP 02.98.201 T/Line Fall Arrest Attachment Point (FAAP).
