Failure of substation conductor fittings

Quality Alert REF No: 2024-002

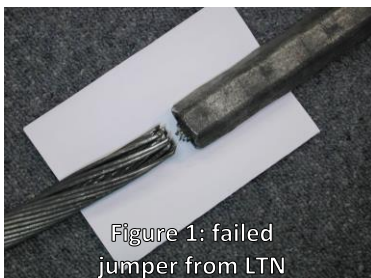
The failure of jumpers (one at Linton and one at Wilton) occurred due to fatigue resulting from a combination of excessive movement and twisting in the conductor.

- Jumpers that are loosely constrained experience large displacements due to wind, producing a large oscillating load in the fixed end
- Lugs that are pressed with the conductor slightly misaligned or twisted, producing torsional stresses when they are bolted into position
- Excessive motion and/or twisting results in a loading case that causes fatigue failure in the jumper

Spacers and fittings attached too close together can cause bird caging which in turn places extra stress on the aluminium strands at crimped end, leading to fraying.

- Wind causing excessive movement of conductors and fittings, as this can cause failure
- The signs of wear on conductors such as fraying, and build-up of Aluminum oxide
- The need to visually inspect conductors and fittings with binoculars or drone during inspection on assets
- SMP 02.43.004 Task No. 3.3 (soon to be updated/issued) which clarifies unacceptable damage

- All Service Providers and Transpower Service Delivery Managers should report any jumpers/attachment points showing excessive movement or any damage to Operational Engineering
- It is essential that pressed fittings are installed using correct methods and minimal twisting is induced in the conductor as per MCG-02.97-5.1.2.10 and the manufacturer's instructions
