### **Interruption Report: Waioatahe loss of supply, 12/13 April 2026**

## INTERRUPTION REPORT: WAIOTAHE LOSS OF SUPPLY, 12/13 APRIL 2026

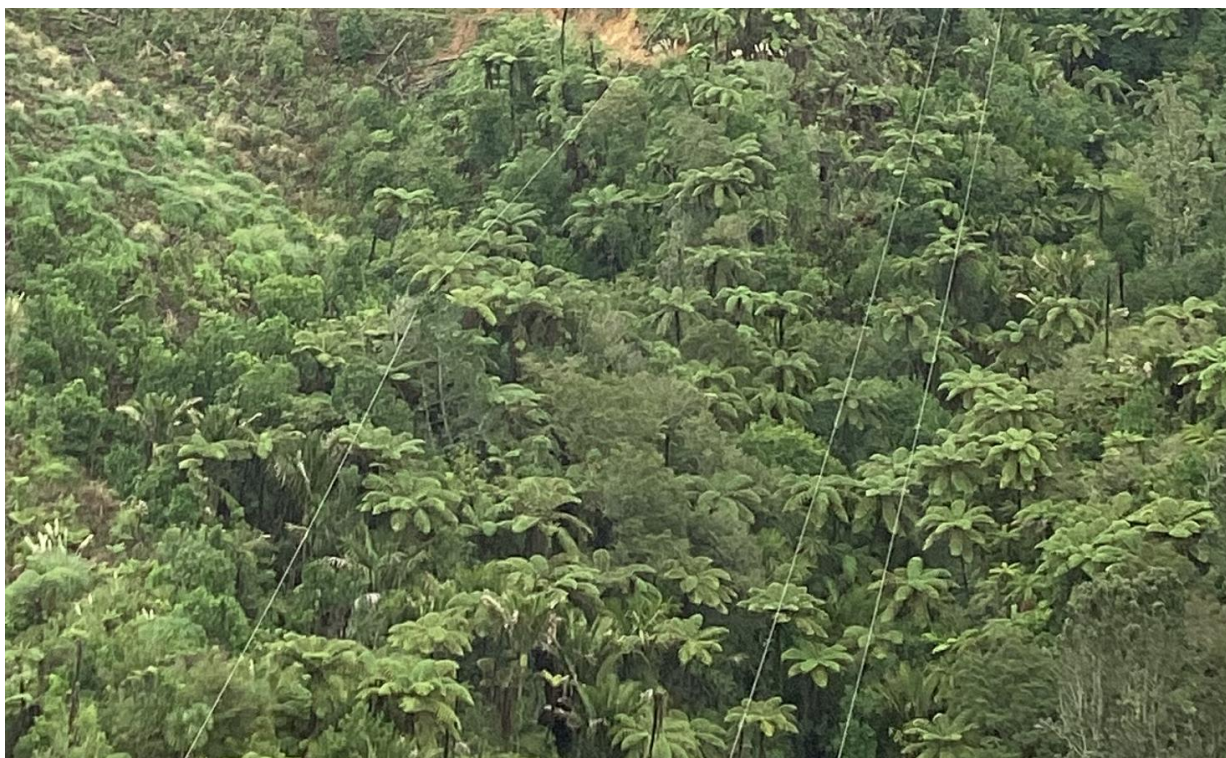
Figure 2: Span 107-108 of the EDG–WAI 2 circuit

The unplanned interruption was caused by conductor spans becoming caught in trees with a forestry area traversed by the circuit. Three spans were identified as affected; however, the exact sequence and timing of these contacts could not be determined.

<sup>5</sup> All were mid span – on spans 78-79, 96-97 and 107-108.

- Once the fault locations had been identified, and given the conductors were undamaged, carried out a risk assessment to determine how best to return the conductors to their normal position. A helicopter lift was determined to be safe and would minimise the outage period. Ground crews were readied as a back-up, in case the aerial approach was not successful.
