### **Interruption Report: Hawkes Bay Loss of Supply – 28 October 2025**

## INTERRUPTION REPORT – HAWKES BAY LOSS OF SUPPLY, 28 OCTOBER 2025

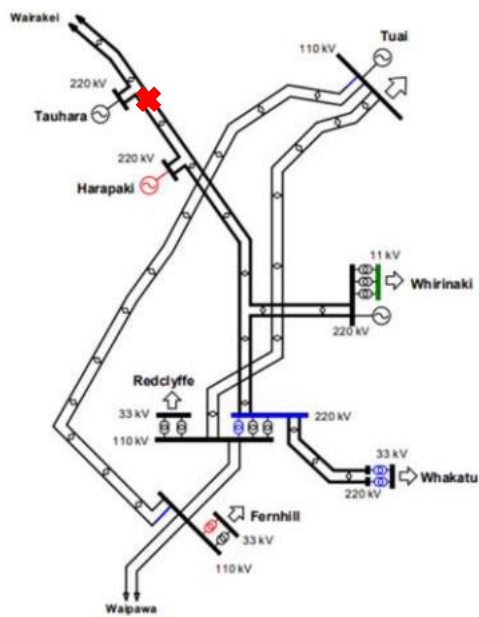
At 2.33am on 28 October 2025, the 220 kV Whirinaki–Wairakei–1 (WHI–WRK–1) and Harapaki–Tauhara–1 (HRP–TAB–1) circuits tripped due to simultaneous 3 phase to earth faults caused by lightning strikes at Tower 54 at the Taupo end of the circuits.<sup>1</sup> Both circuits tripped all three phases. This disconnected Harapaki (HRP), Whirinaki (WHI), Redclyffe (RDF) and all stations supplied off the Redclyffe bus. Both grid side circuit breakers Wairakei (WRK) and Tauhara (TAB)) auto reclosed after a successful dead-line check, but the HRP and WHI breakers did not reclose as the synchronisation check<sup>2</sup> conditions for a reclose were not satisfied, due to both these buses being isolated and having no voltage supply. The anti-islanding protection at HRP operated correctly, isolating the generation at the site as the “island” conditions had been met.<sup>3</sup> All protection operated correctly.

Figure 1: Transmission system schematic (red X shows the approximate location of tower 54, near Tauhara)

The unplanned interruption was due to lightning striking in the vicinity of tower 54, causing a flashover to conductors on the 220 kV WHI–WRK–1 and HRP–TAB–1 circuits. Both grid side circuit breakers auto reclosed, but synchronisation check conditions were not satisfied at the HRP and WHI breakers, so they did not auto reclose. All protection operated correctly.
