Interruption Report: Maraetai Bus C – 24-25 September 2023

INTERRUPTION REPORT – MARAETAI BUS C INTERRUPTION 24-25 SEPTEMBER 2023

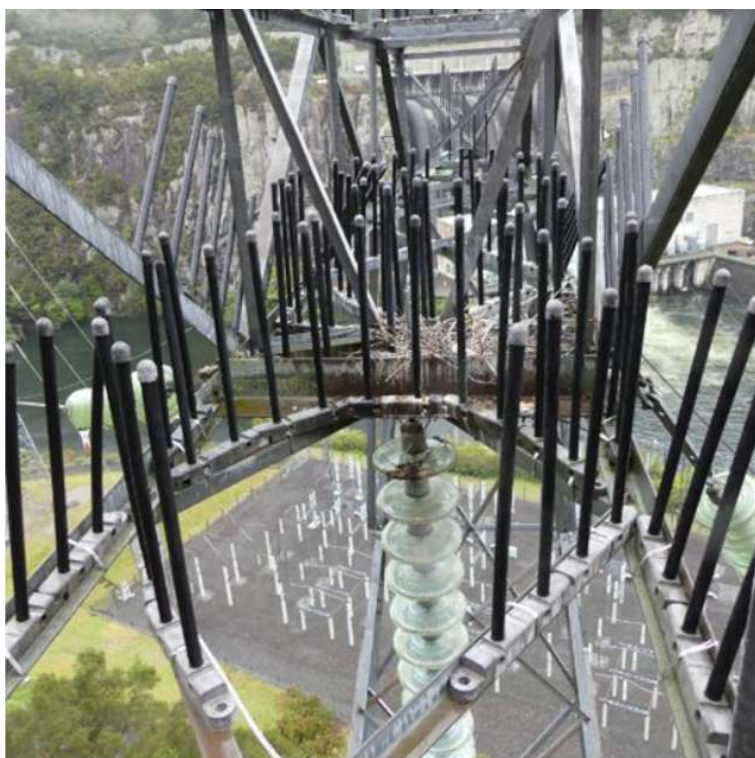
A flashover² caused the MTI 220 kV Bus C to trip, resulting in loss of the MTI–WPA–1 220 kV circuit, and connection to the WPA generator. The flashover was caused by bird streaming on a bus tie line transmission tower, from a heron's nest located directly above the centre phase insulator string.

- had, following historical bird activity at this site, installed bird deterrents (as shown in Figure 1) on the affected tower and other nearby equipment, and installed bus couplers to minimise interruption impact³. However, the bird was able to construct a nest within the 'bird spikes';
- immediately dispatched a service provider to inspect the bus. Within two hours of the tripping (1811 hours), the service provider had identified the issue, and found the bird nest;
- decided that, for safety reasons (daylight and weather concerns), removal of the nest should be deferred to the following morning, at which time it was carried out as soon as was practicable;
- communicated with Mercury Energy regarding the interruption, both immediately following the event and throughout the period of the interruption.

Figure 1 – Bird nest as found, within the existing bird spikes

Bird deterrents and mitigations were applied at MTI in 2014-16, following a series of faults attributable to bird activity. This included installing 'bird spike' deterrents (designed to deter large species, such as herons) on the towers that make up the MTI bus, together with some guards on the rooftop bus. Bus couplers were installed, to reduce the impact of interruptions. Activity at the site was relatively quiet for a number of years after this was completed. However, following the recent interruption, it was found that a heron had managed to construct a nest within the deterrents.

We have decided to apply a further engineering solution at this site. This consists of pyramid shaped Bird Cones (shown in Figure 2) which are being positioned above the insulator strings to provide additional shielding from bird streaming, with a mesh on the underside to prevent small birds nesting inside. These were developed for use on the Islington–Livingstone circuit. These will be installed in conjunction with a future planned outage at the site.

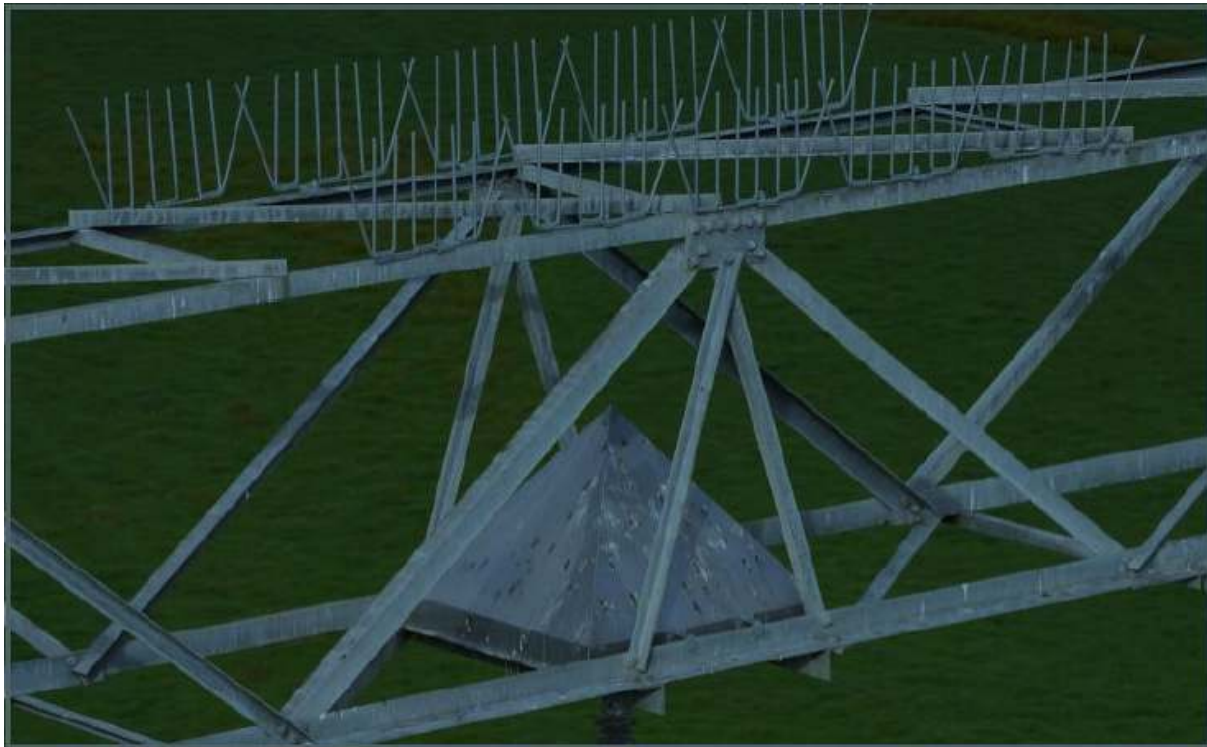
Figure 2 – Bird Cone to be fitted to the MTI Bus Tie line above the middle phase insulator string
