## Substation Security Breaches

### WHAT HAPPENED?

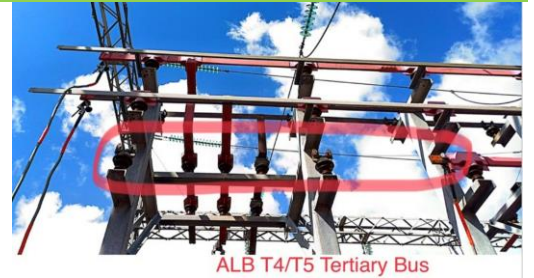
ALB T4/T5 Tertiary Bus

Within the past 8 months, we have had 10 reported security breaches into substations within the RSA1 region across multiple sites where project equipment was taken and cable on cable drums was tampered with or taken. On 25/3/24 it was reported that Albany substation was broken into where the intruders have cut away earth from multiple pieces of primary plant. The sites where we have had security breaches include Penrose, Henderson, Huapai, Drury, Mt Roskill, Otahuhu and Albany

- Report raised in Maximo
- Police report filed
- Thorough check done onsite (Albany) to check the extent of what was taken and an immediate plan put in place to re-instate the earthing
- Hazard boards updated to state that anyone starting work on site needs to thoroughly check that the equipment they are working on and adjacent equipment has earthing intact

- When working onsite, thoroughly check that the equipment and adjacent equipment that is being worked on has its earthing intact
- Be vigilant when onsite and if any suspicious behavior is spotted, get yourself and others to safety and notify the correct personal
- Engaged in discussions on security improvement
- All RSA1 substation hazard boards to be updated to check that the equipment and adjacent equipment that is being worked on has its earthing intact
- Reminder to report any break ins / security breaches to the police
- Reminder not to leave anything out in the open that could be attracting people to the sites
- Reminder when leaving site to check that all gates are locked and the site is secure.
