Iberian Peninsula Blackout - 28 April 2025

Overview of the event and the lessons for NZ

System Operator

June 2026

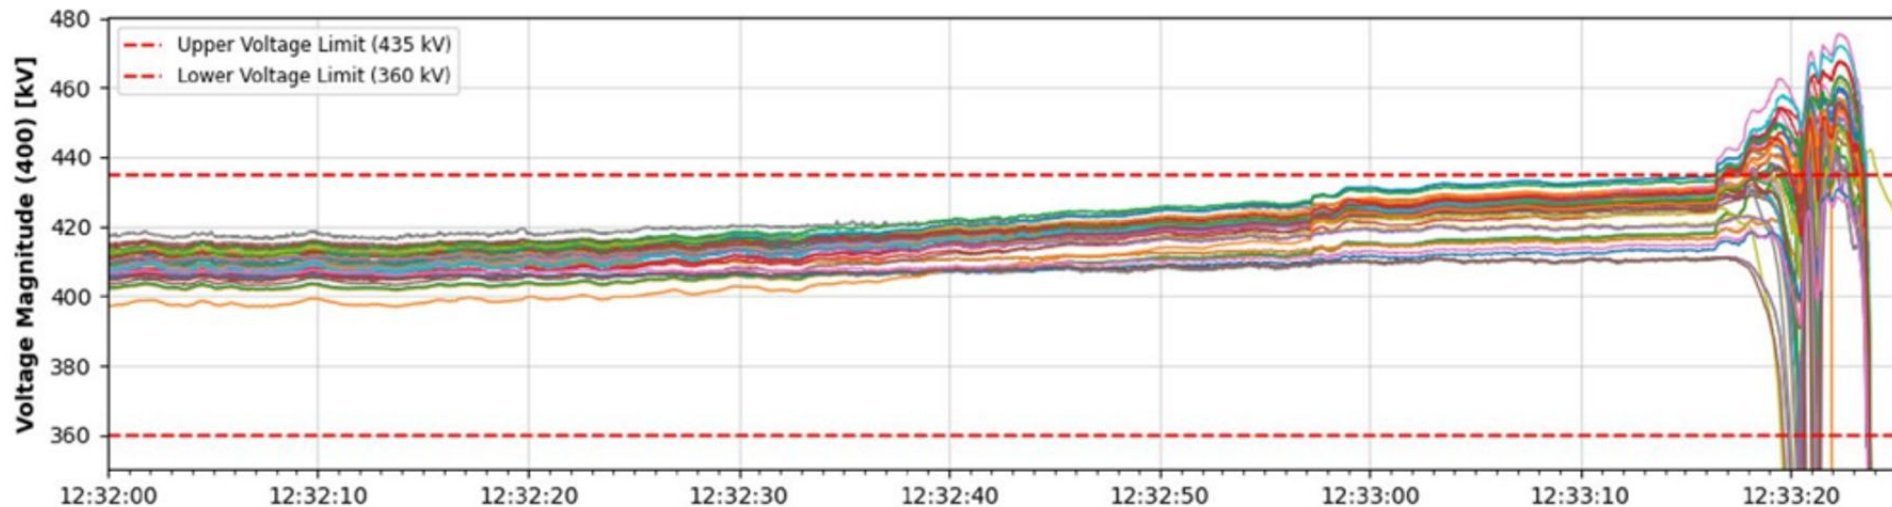
The morning: The day began as normal. Weather was mild and sunny, wind and solar generation were typical for the season and Spain was exporting several GW of power to other regions. Voltage levels were within acceptable bounds but showing increasing variability from around mid-morning. There was no single warning sign—just a slightly “restless” voltage profile developing through the morning. The penetration of renewables, particularly solar, was climbing up to about 55% by the time of the event. By late morning, the system was technically stable, but with reduced resilience—particularly to disturbances.

The ‘midday’ Oscillations, actions to dampen them and climbing voltages: At around 12:00 noon, the system operator observed two distinct oscillation events. The first had a mode around ~ 0.6 Hz, driven by a solar PV plant in Badajoz, Spain, and seen locally. The second ($\approx 12:19$ – $12:22$) was a known inter-area oscillation (~ 0.21 Hz) across wider Europe. Operators acted to damp the oscillations by reducing cross-border exports and by reconnecting lines to reduce impedance. Whilst these actions helped stabilise the second set of oscillations, they had the unintended consequence of pushing voltages higher across the Iberian system. By around 12:30–12:32: Oscillations had stopped, but voltage had become dangerously high and poorly controlled.

Over-voltages and system collapse: What happened next was fast. Voltage rose toward operational limits and appears to have triggered initial generator disconnections. Each generator that tripped or ramped down removed reactive power absorption and caused voltage to increase further. This triggered even higher voltage, more trips, interconnectors were disconnected to protect other regions, and the system collapsed.
