TRANSPOWER

# HVDC Link Upgrade Programme Major Capex Proposal (Stage 1)

Attachment 3: Cable Condition Assessment Report

September 2025

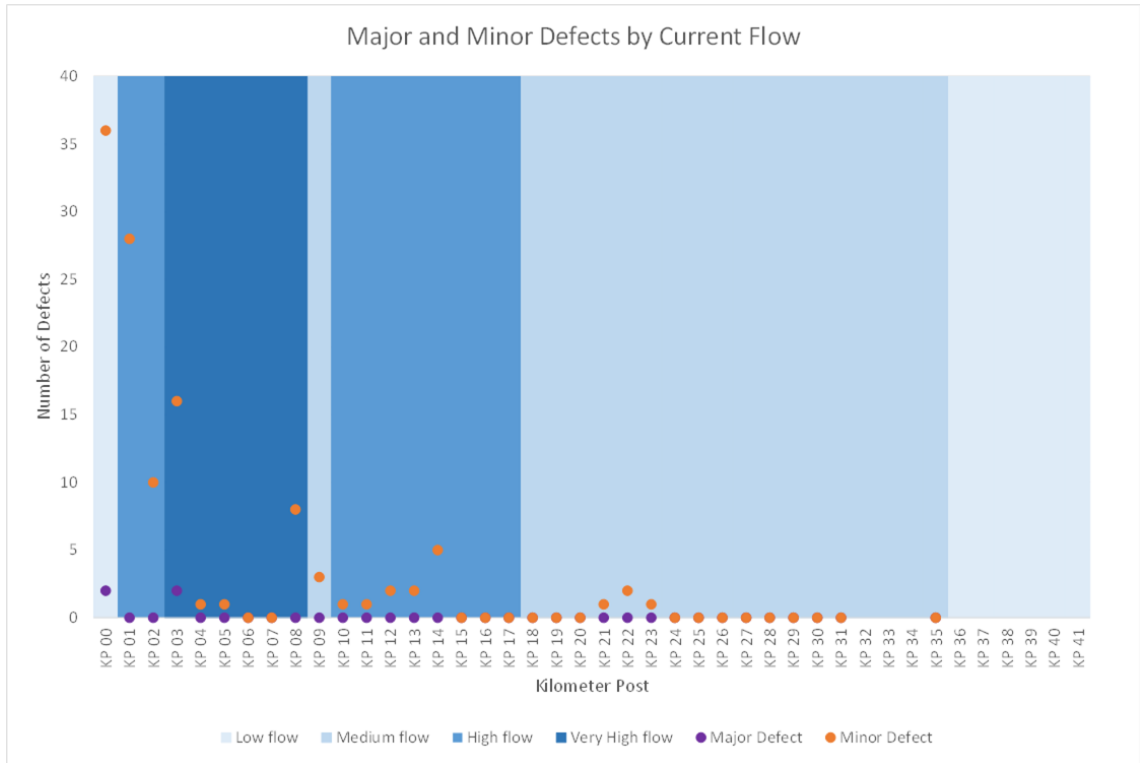
Charts below show the location of defects relative to KP, relative to tidal currents and relative to seabed composition. The majority of defects are at the Oteranga Bay end where tidal current velocities are highest, and where the seabed composition is more aggressive e.g. boulders.

Different coloured dots represent major defects (purple) and minor defects (orange). The shades on the graph indicate the current velocity. Highest currents can reach 3 m/s, this velocity is unique to our NZ situation. A darker shade points to higher current velocity. Note that the end with the higher current velocity had more observed defects.

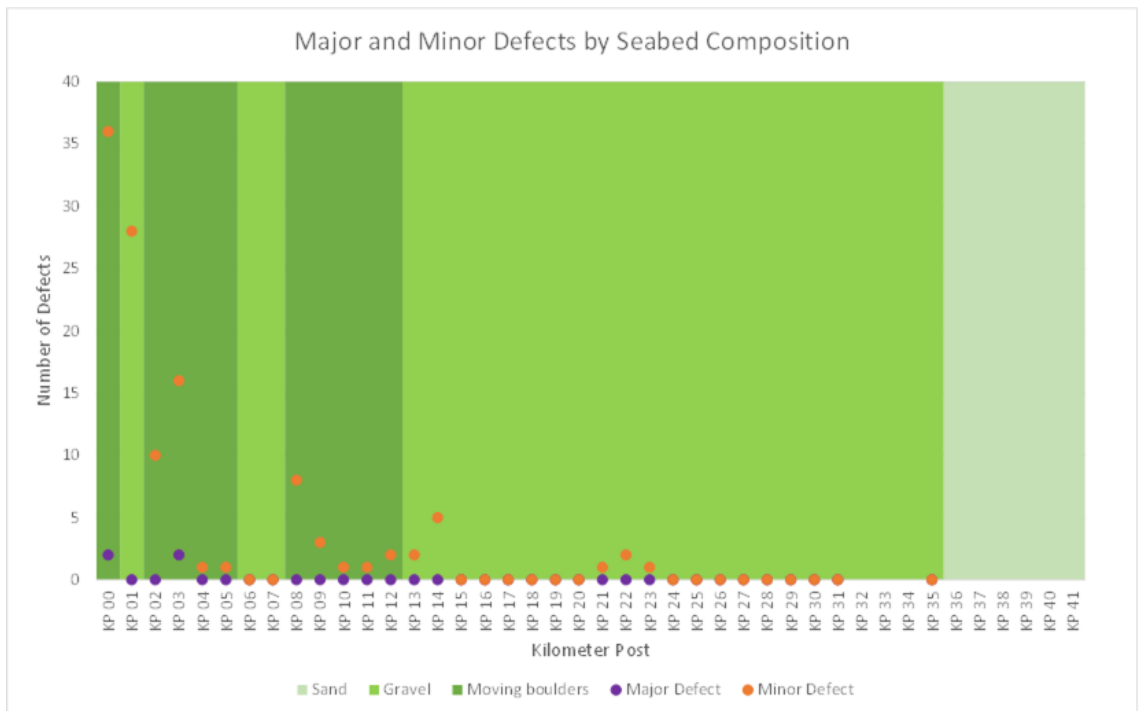
The shades on the graph indicate seabed composition. Darker shades were used for more aggressive seabed. This can move around with the current and the end of the graph with aggressive seabed had more observed defects.

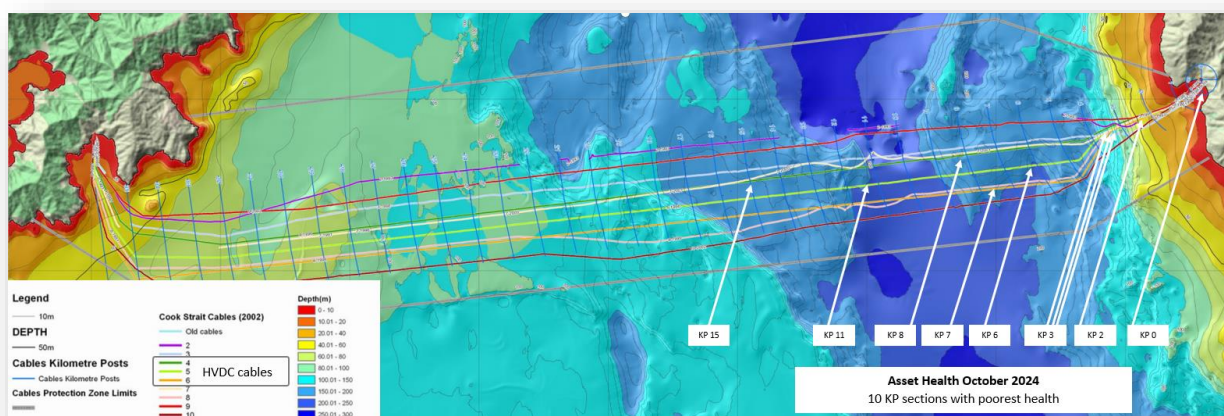
## Sections with Poorest Health

The ten sections of cable with the poorest current asset health score are shown in the diagram and table below. These sections are submerged at a range of depths, mostly in the highest tidal flow areas, with the most aggressive seabed composition (moving boulders). These sections also have a number of major and minor defects.

HVDC Cable	km post (KP)	Current Health	Major Defects	Minor Defects	LIRA Delta G	LIRA D Norm <sup>5</sup>	Seabed Composition	Current flow	Depth submerged
W4	3	5.40	1	9	16.8	-	Moving Boulders	Very High	25-150m
W4	8	4.89	0	6	16.8	-	Moving Boulders	Very High	150-200m
W4	0	4.77	2	14	16.8	-	Moving Boulders	Low	0-20m
W4	15	4.25	0	0	16.8	-	Gravel	High	100-250m
W5	3	5.30	1	3	27.6	-	Moving Boulders	Very High	25-150m
W5	6	3.99	0	0	27.6	-	Moving Boulders	Very High	150-200m
W6	11	4.67	0	1	22.6	-	Moving Boulders	High	100-250m
W6	3	4.32	0	4	22.6	-	Moving Boulders	Very High	25-150m
W6	7	3.99	0	0	22.6	-	Moving Boulders	Very High	150-200m
W6	2	4.17	0	6	22.6	-	Moving Boulders	High	25-90m

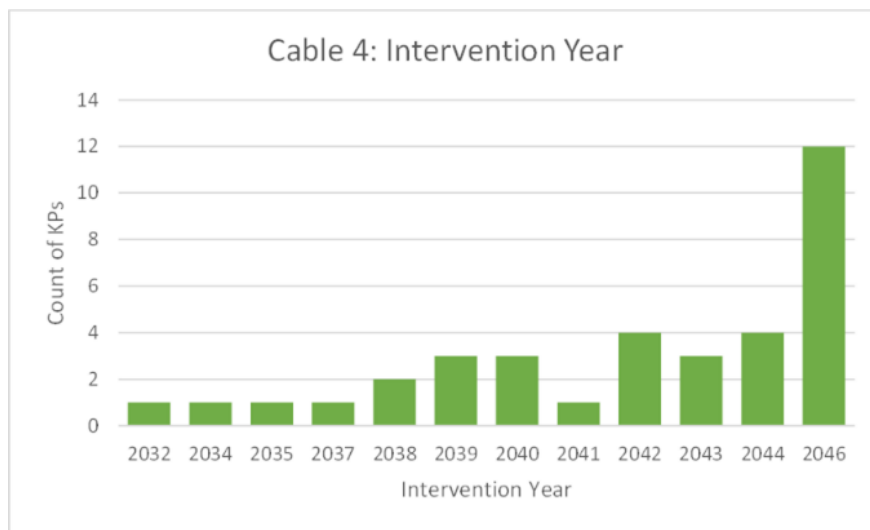
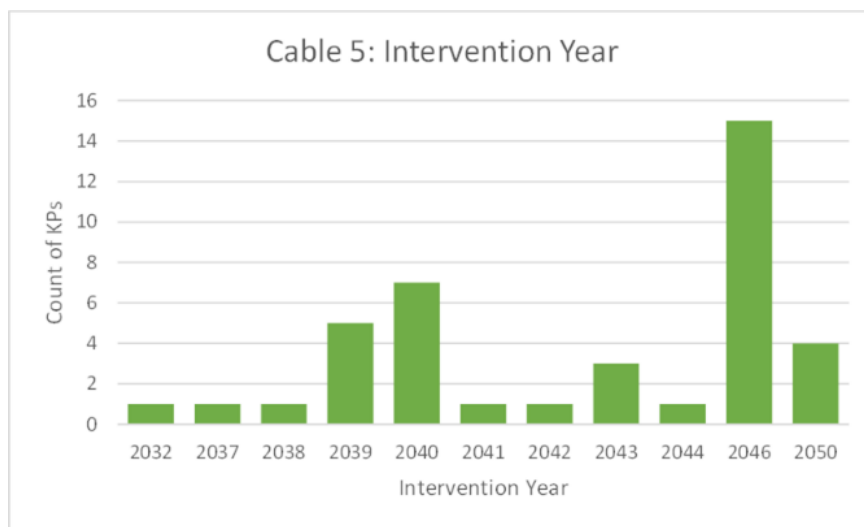
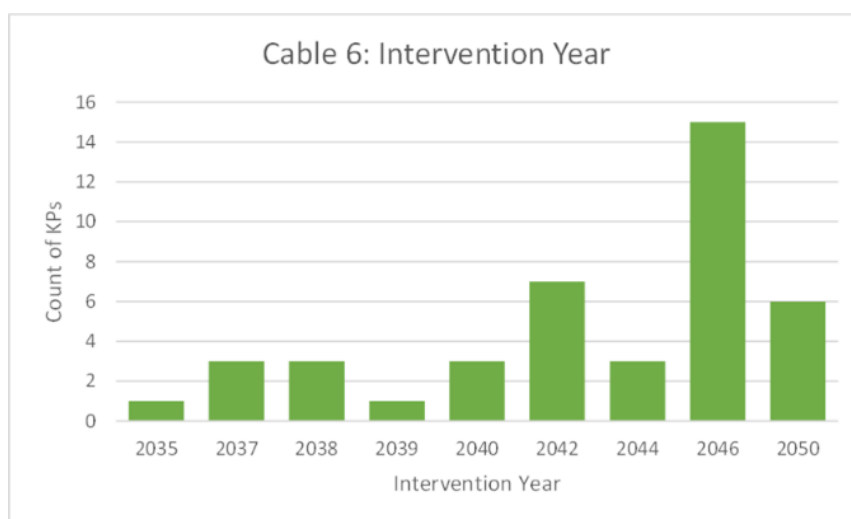
All KP sections of the cables are expected to reach a score of 8, but at different times. For example, in the first chart below for Cable 4 the earliest is in 2032, with six sections requiring intervention by 2038. Overall cable health is determined by the weakest section, as the failure of a single section would compromise the entire cable.

Cables 4 and 5 have the earliest intervention year in 2032, and cable 6 has the earliest intervention year of 2035. Some sections of the cable are expected to have a much longer

service life primarily due to the more benign conditions and lack of defects at the Fighting Bay end.

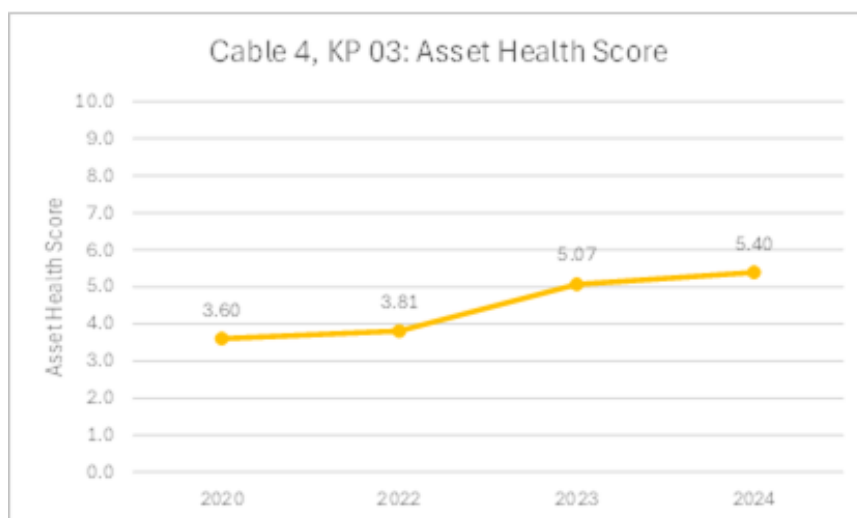
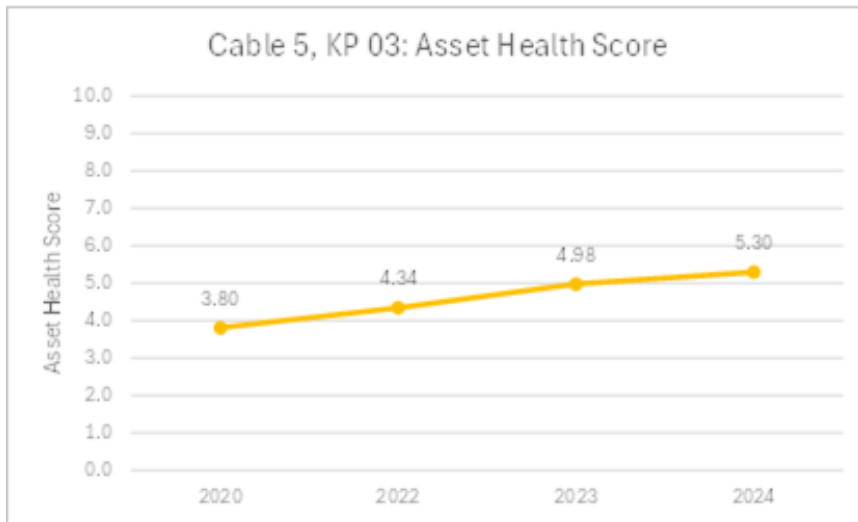
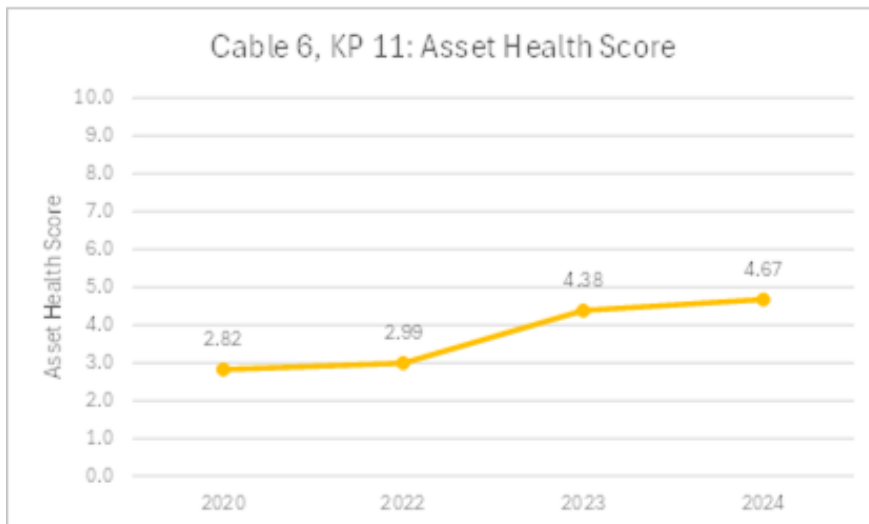
Our 2024 assessment has resulted in an earlier predicted year for intervention for each of the three cables. This is primarily due to the discovery of additional defects and changes to the seabed close to the North Island end of the cable route in the last few years, as well as the consideration of the cables age.

The changes to the poorest sections are shown year on year in the charts below.
