## 400V Switchboard Arc Over Event

### Background:

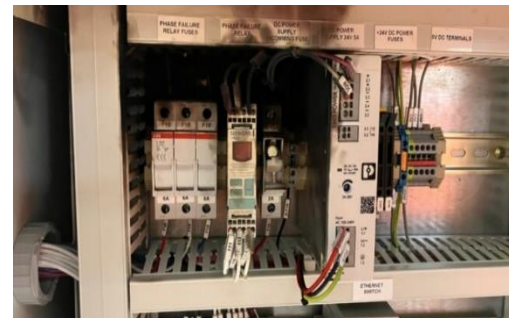
- Following the commissioning of the new 400 V LVAC Board, the HMI screen on the board wasn't working which was proven to be working in pre-livening checks.
- To investigate, the control cabinet was opened, and the suspected fuse was inspected which revealed a loose wire that was close to touching the earth. A MCB was switched off to isolate the loose wire.
- Following that individual went ahead to test and prove that the loose wire was not live. This action dislodged the wire which happened to be not isolated leading to a phase-to-earth fault. The fault resulted in a flashover and vaporizing of a section of the wire.

*Affected controls cabinet*

- Investigation commenced. Early indication is that a manufacturing error may be a cause.
- All those installing this equipment, be vigilant and check wiring terminations to ensure they are secure.
- Always ensure that the correct PPE is worn for the task.
