# **ABB NVA Earth Switch operated with locking pin**

Quality Alert REF No: 2024-001

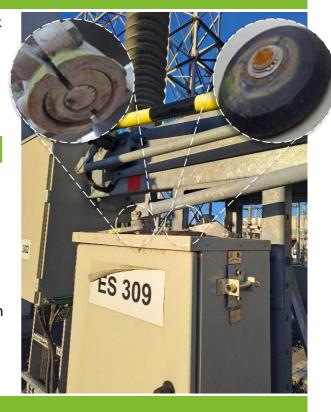
The ABB NVA Earth Switch has a locking pin and padlock that **MUST BOTH** be removed before the Earth Switch (ES) is operated. Failure to remove the locking pin will result in shearing of the drive shaft when the ES is operated. This has occurred on three NVA ES and is applicable for all ABB NVA or NVB ES.

Operation of ES with locking pin still attached, while the ES operating mechanism SM800 is equipped with an integrated slip clutch, the slip clutch is:

- not designed to stop the force of the mechanism being operated with the locking pin still attached
- only designed to reduce torque at the end of the mechanism rotation stroke as the motor slows down

The locking pin is designed to be stronger than the ES drive shaft so that the ES does not operate inadvertently.

A service instruction will be issued in early 2024 to install warning labels on the front panel of ES operating mechanisms which state the following:

#### "CHECK AND REMOVE LOCKING PIN PRIOR TO OPERATING EARTH SWITCH"

• TP.OG 42.02 Section 15.2 will be reviewed to include a note to explicitly state that both the locking pin and padlock must be removed prior to operating the ES.

- . Both locking pin and padlock MUST be removed prior to operating the ABB NVA earth switch
- The slip clutch is not designed to stop the force of mechanism being operated with locking pin still attached
- All Service Providers SHALL review their switching plans to ensure both the locking pin and padlock are removed before operating the ABB NVA earth switch
